#1880-NS01, NS02, NS03 Moose Creek Waypoints MC-1 to MC-15
May 7, 2020

Road #1880 Segments NS01, NS02, NS03 in Moose Creek. Waypoints MC-1 to MC-15.

Screen-shot from Paper Maps™ mapping app of Moose Creek, Road #1880 in Lazyman Inventoried Roadless Area.

WAYPOINTS (#MC-1-MC-15) for 1880 Moose Creek May 7, 2020 – Gary Ingman

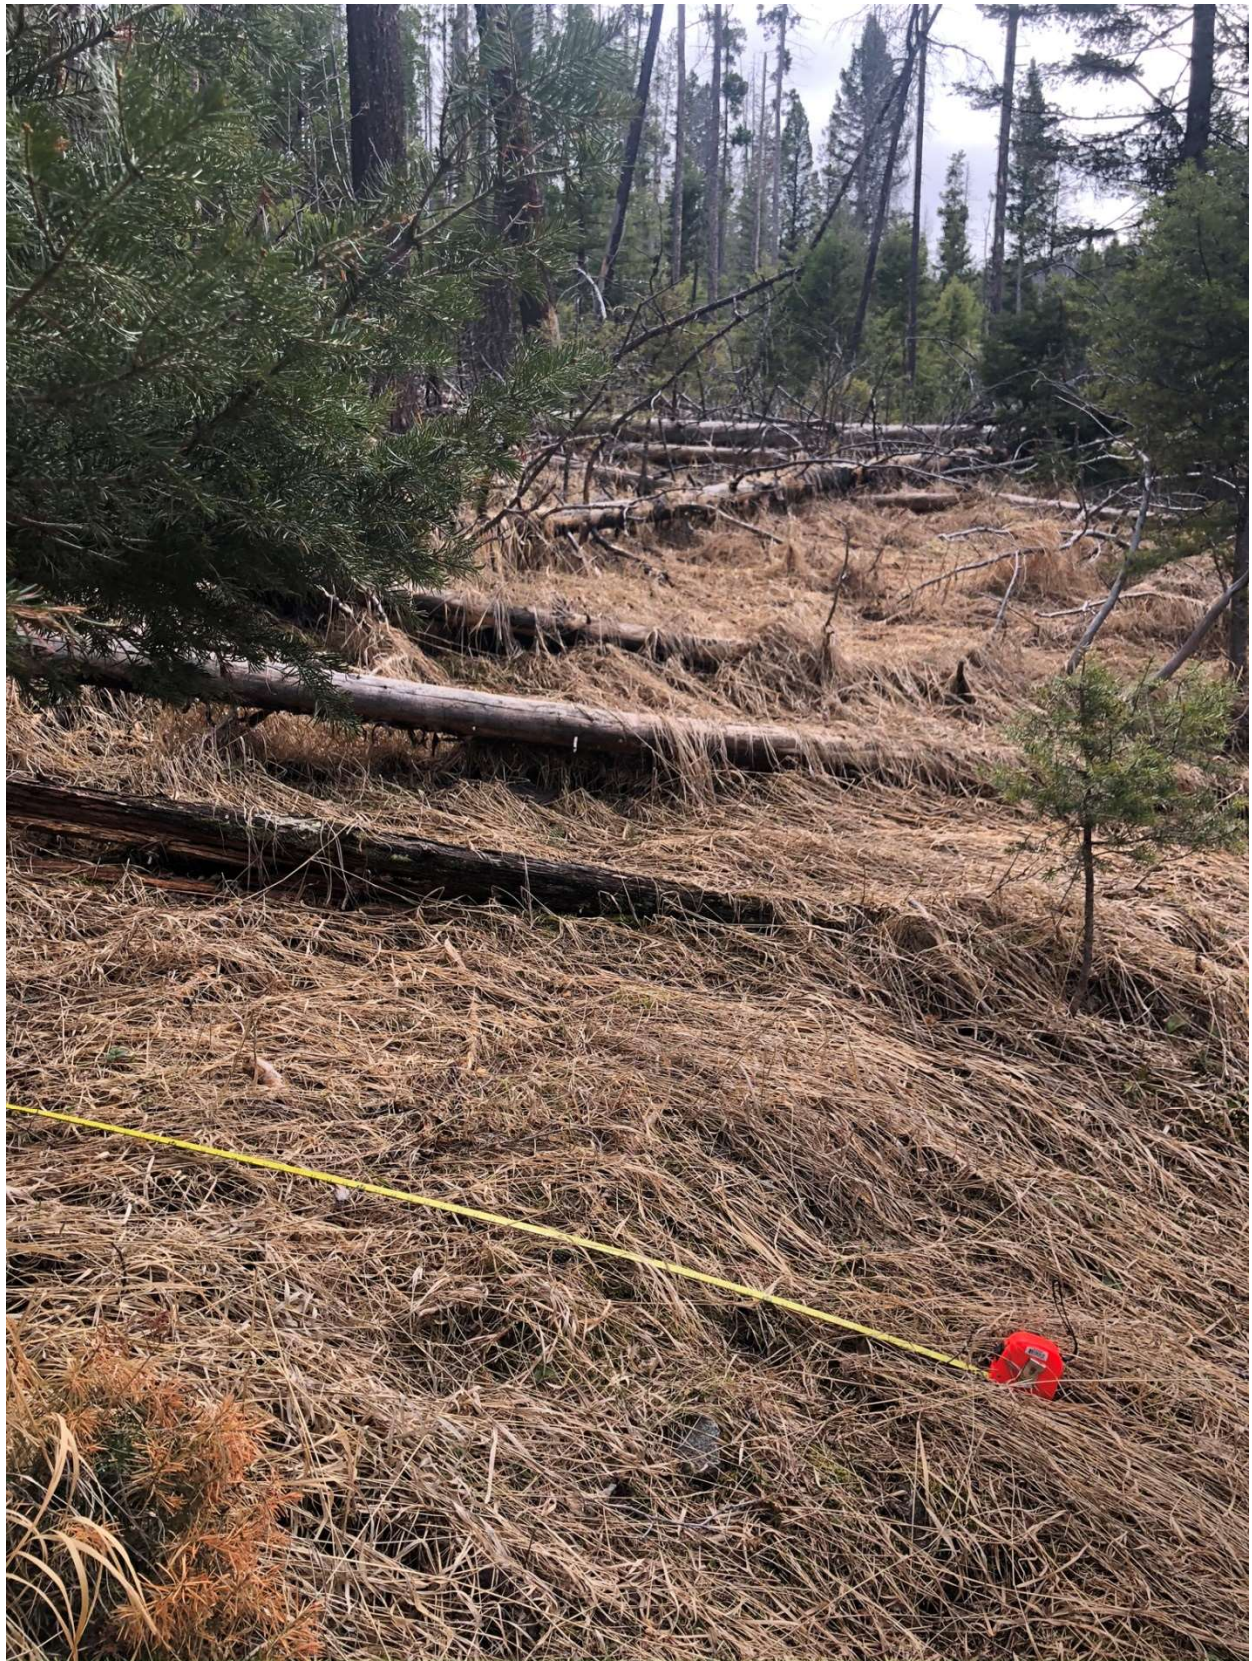
PHOTO NS03-1. Looking SW from upper reaches of NS03. My route was from the upper reaches of the road to the main Moose Creek intersection. Tape measure extended to 6 feet.

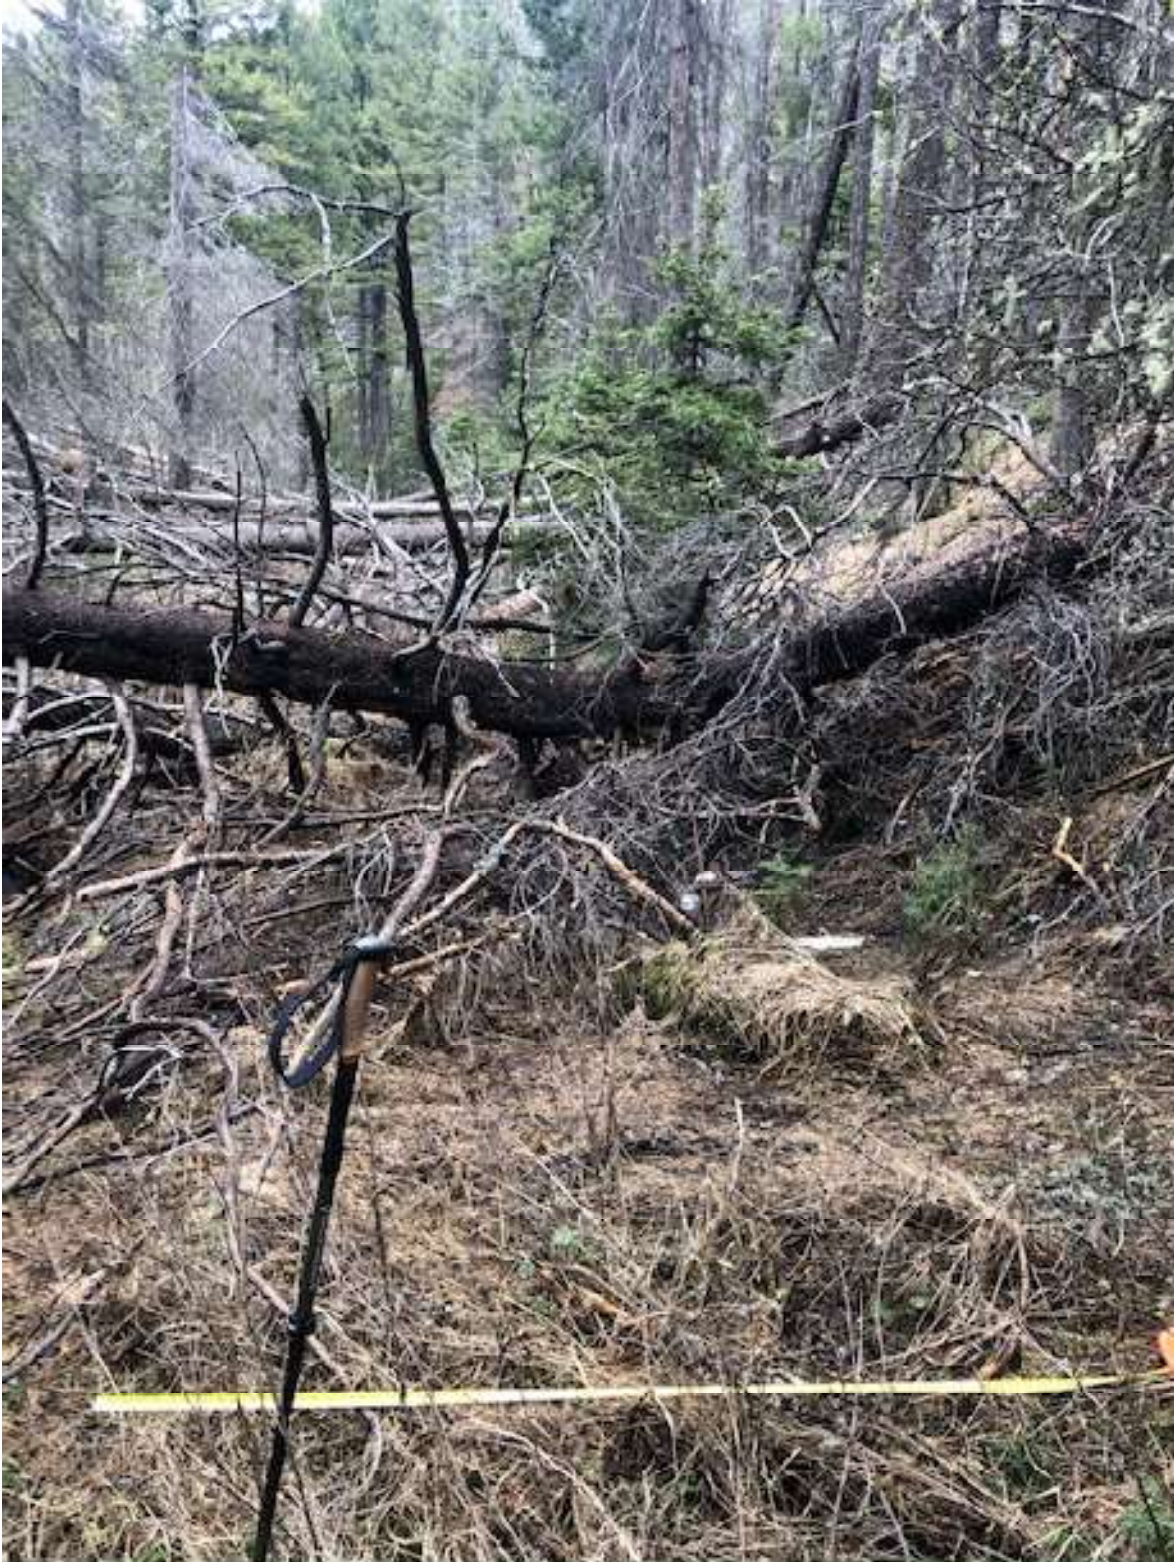
PHOTO NS03-3. Approximately 300 feet further down the road showing extensive blowdown on the roadbed. Tributary creek is on the left side.

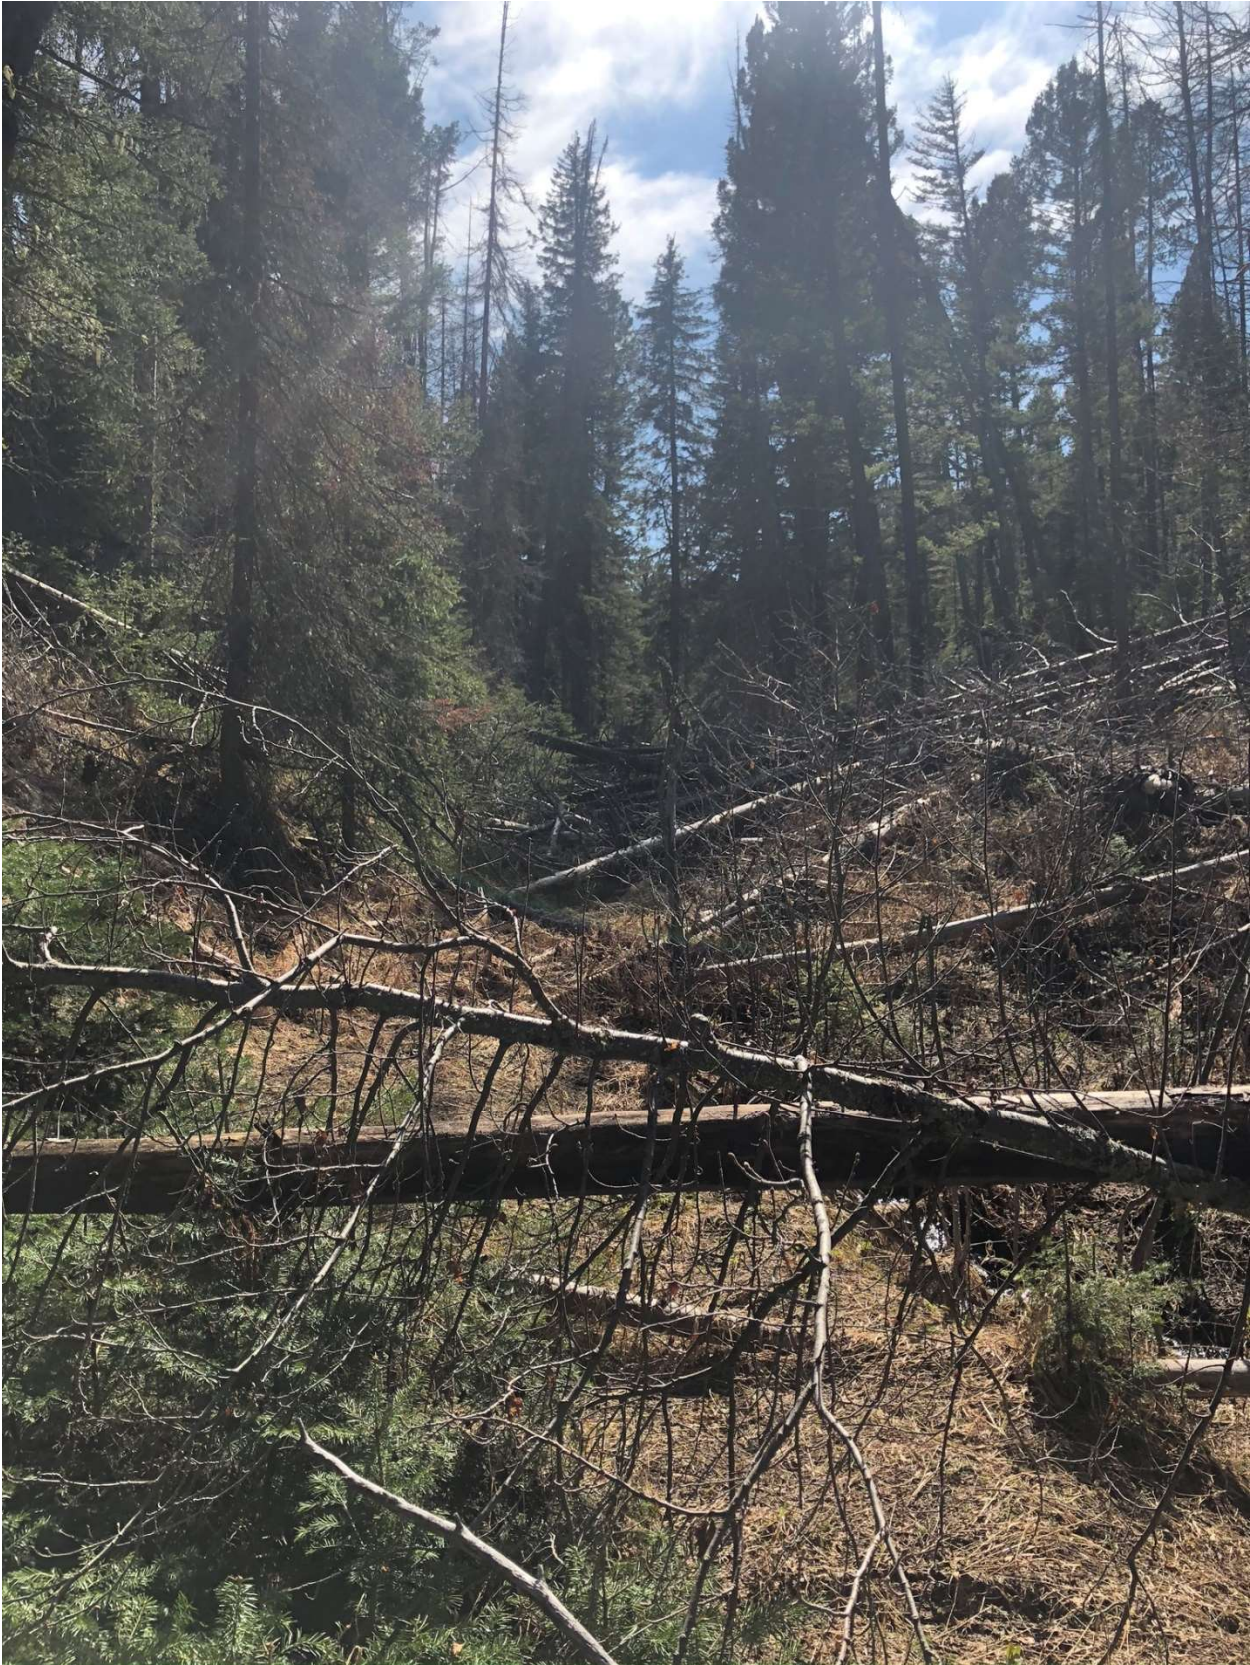
PHOTO NS03-5. Looking SW back up the road with tributary creek on the right.

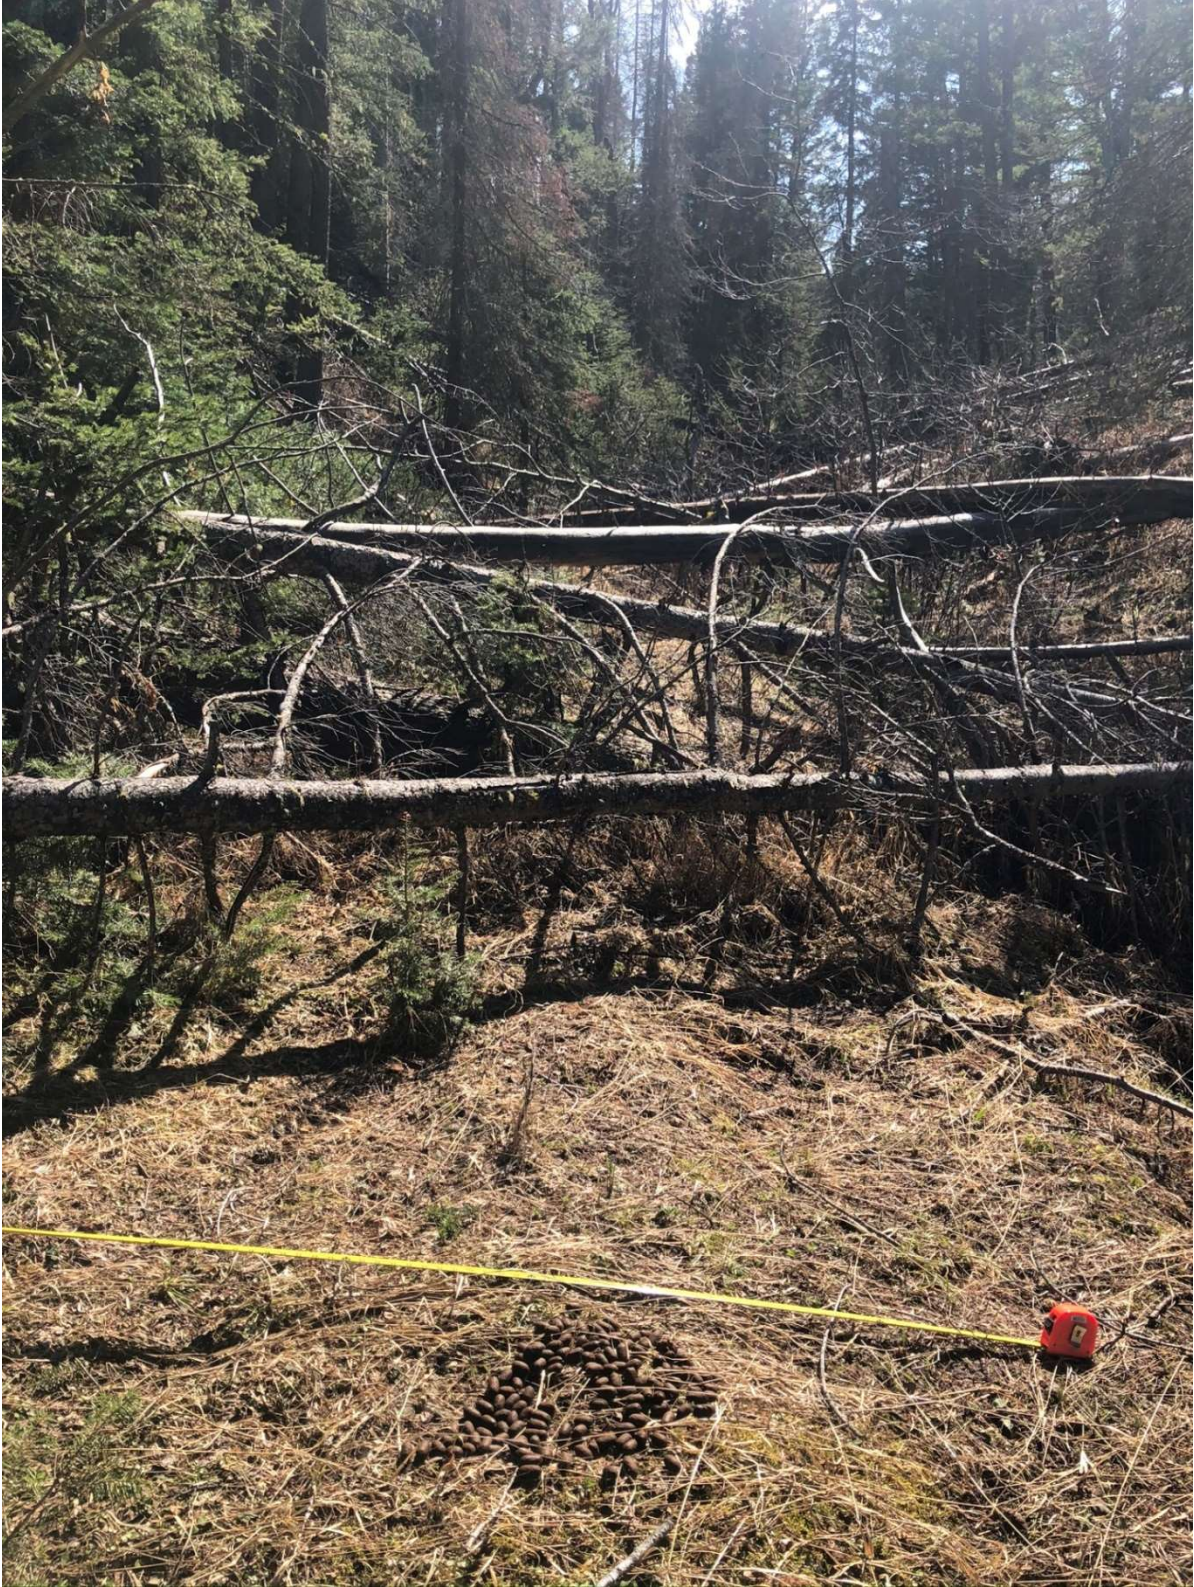
PHOTO NS03-7. Approximately 300 feet further down the road looking back up the drainage from on the road. Moose droppings on the roadbed.

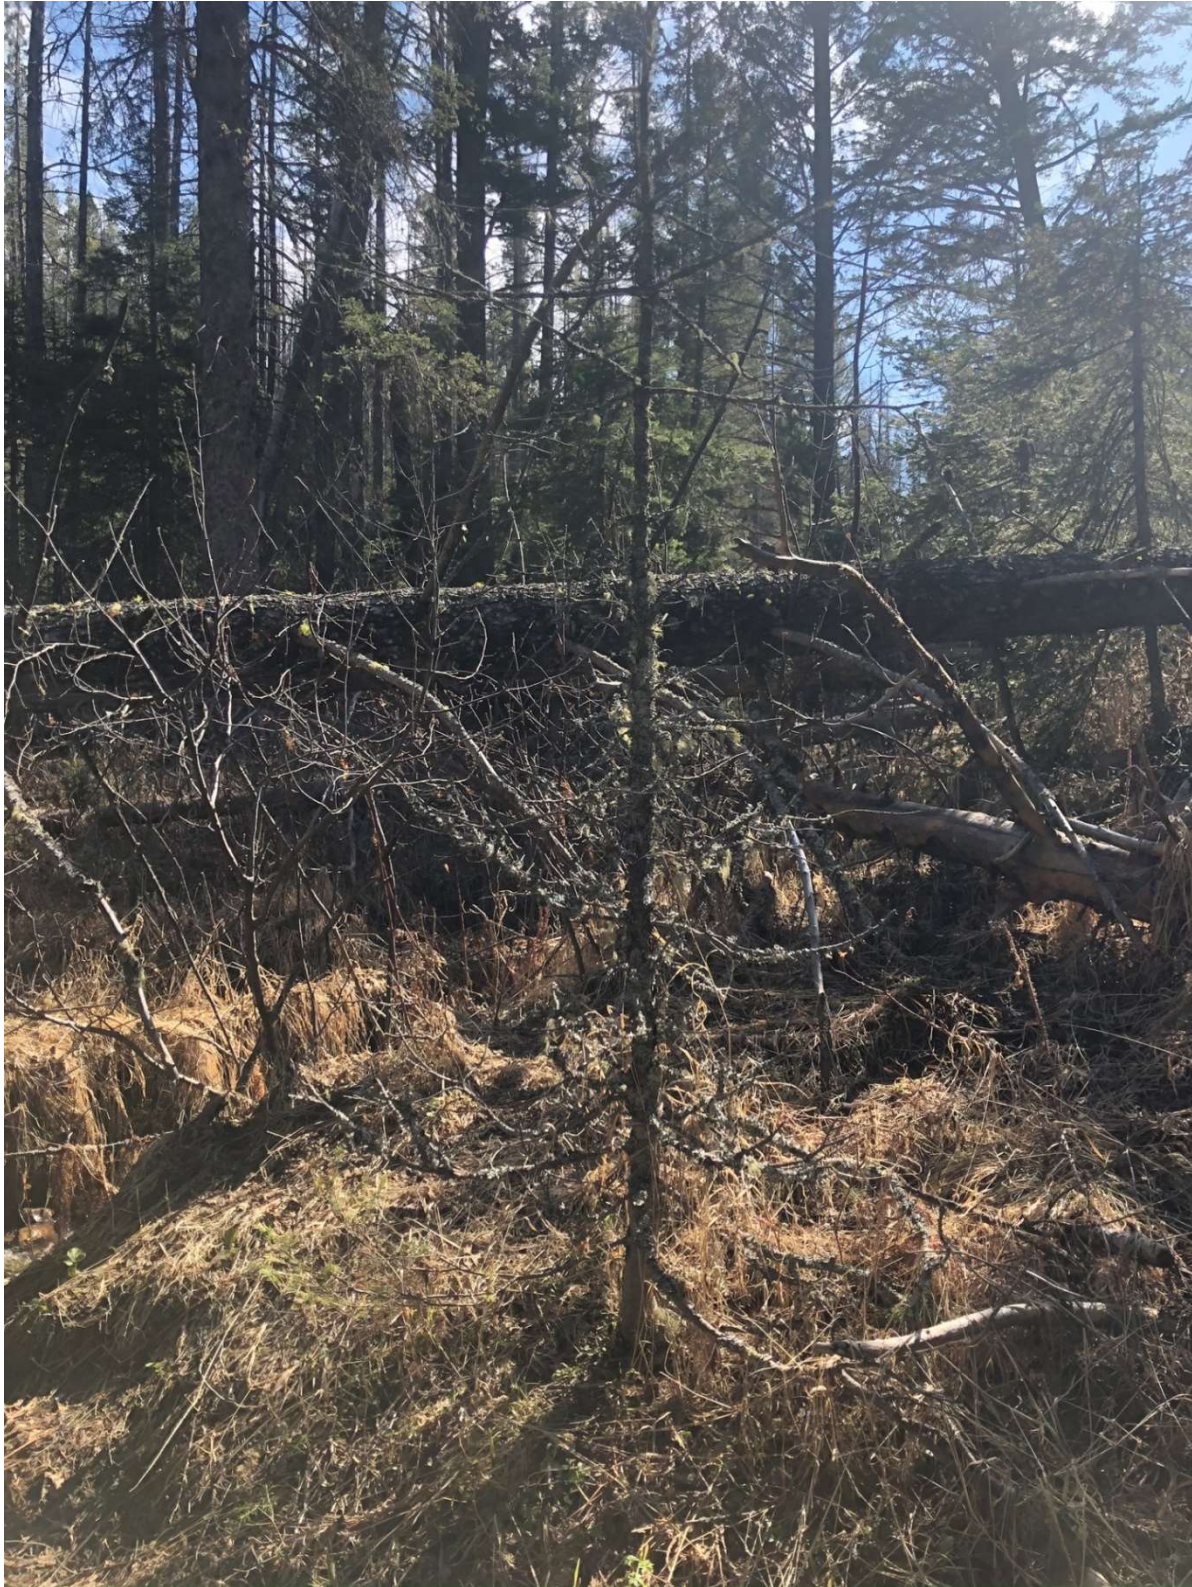
PHOTO NS03-8. End of the road NS03 where it meets main Moose Creek. Looking NE. Moose Creek is just past the downed log.

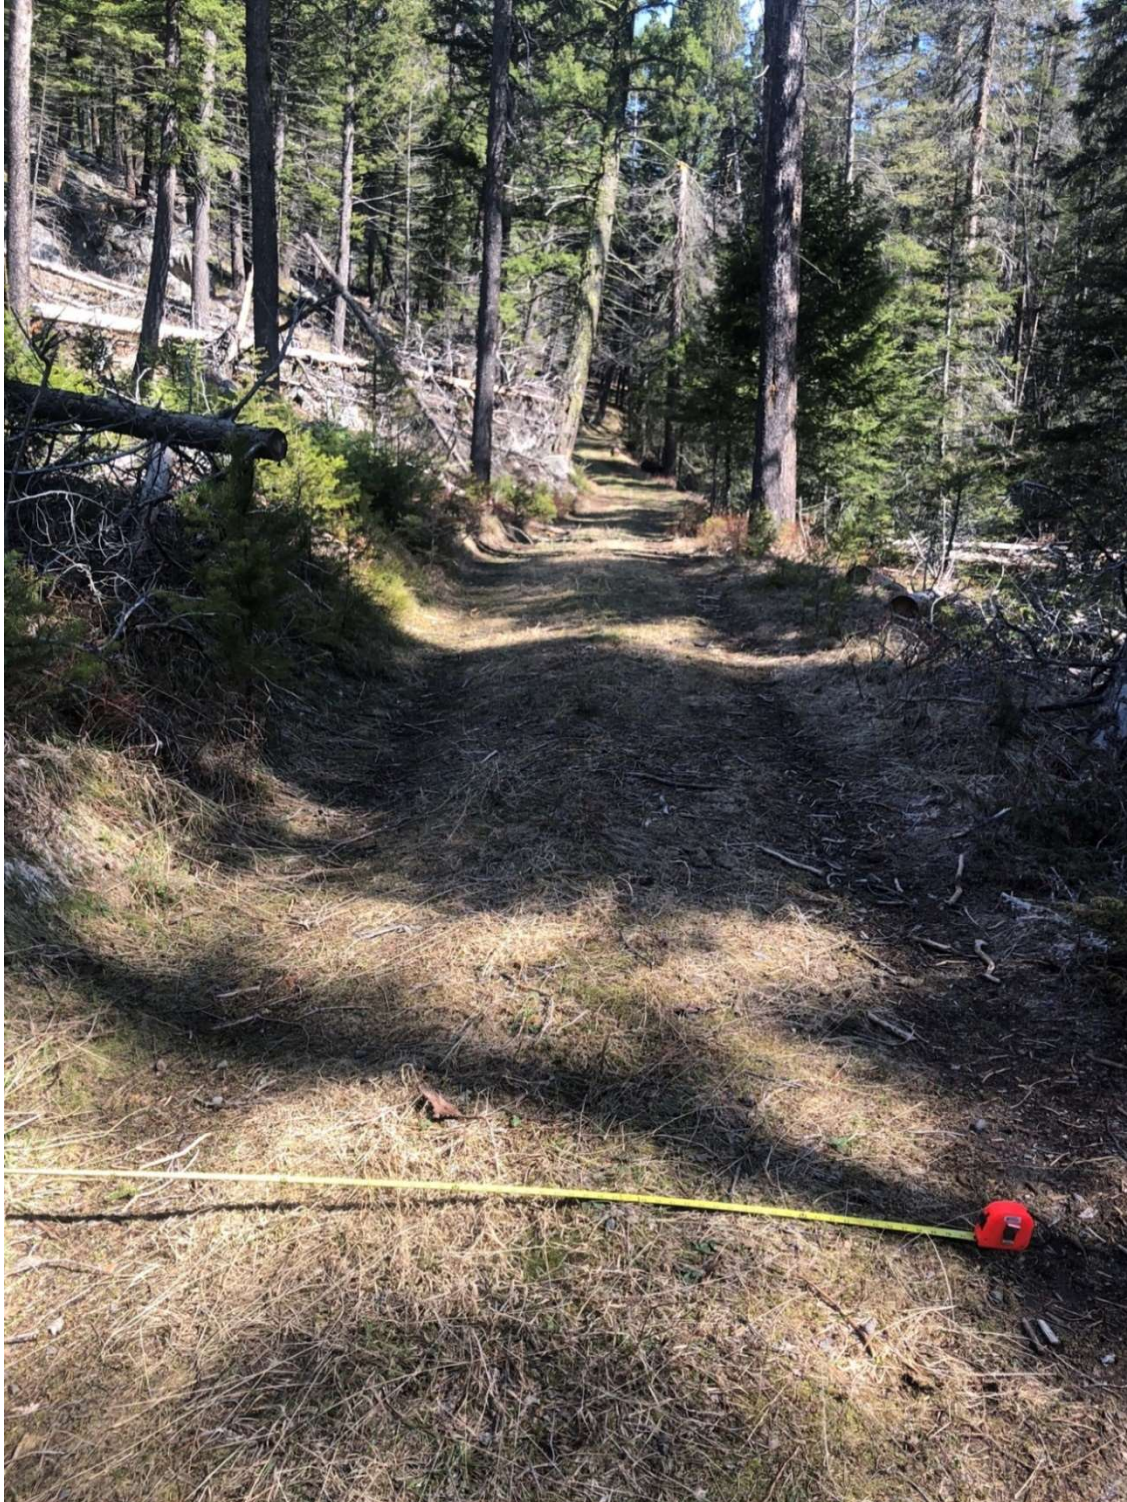
PHOTO NS01-1. Main Moose Creek Road near junction with spur road NS03, looking SE up the drainage in the direction of travel. Tape measure extended to 6 feet. Young fir trees and mature live lodgepole pine.

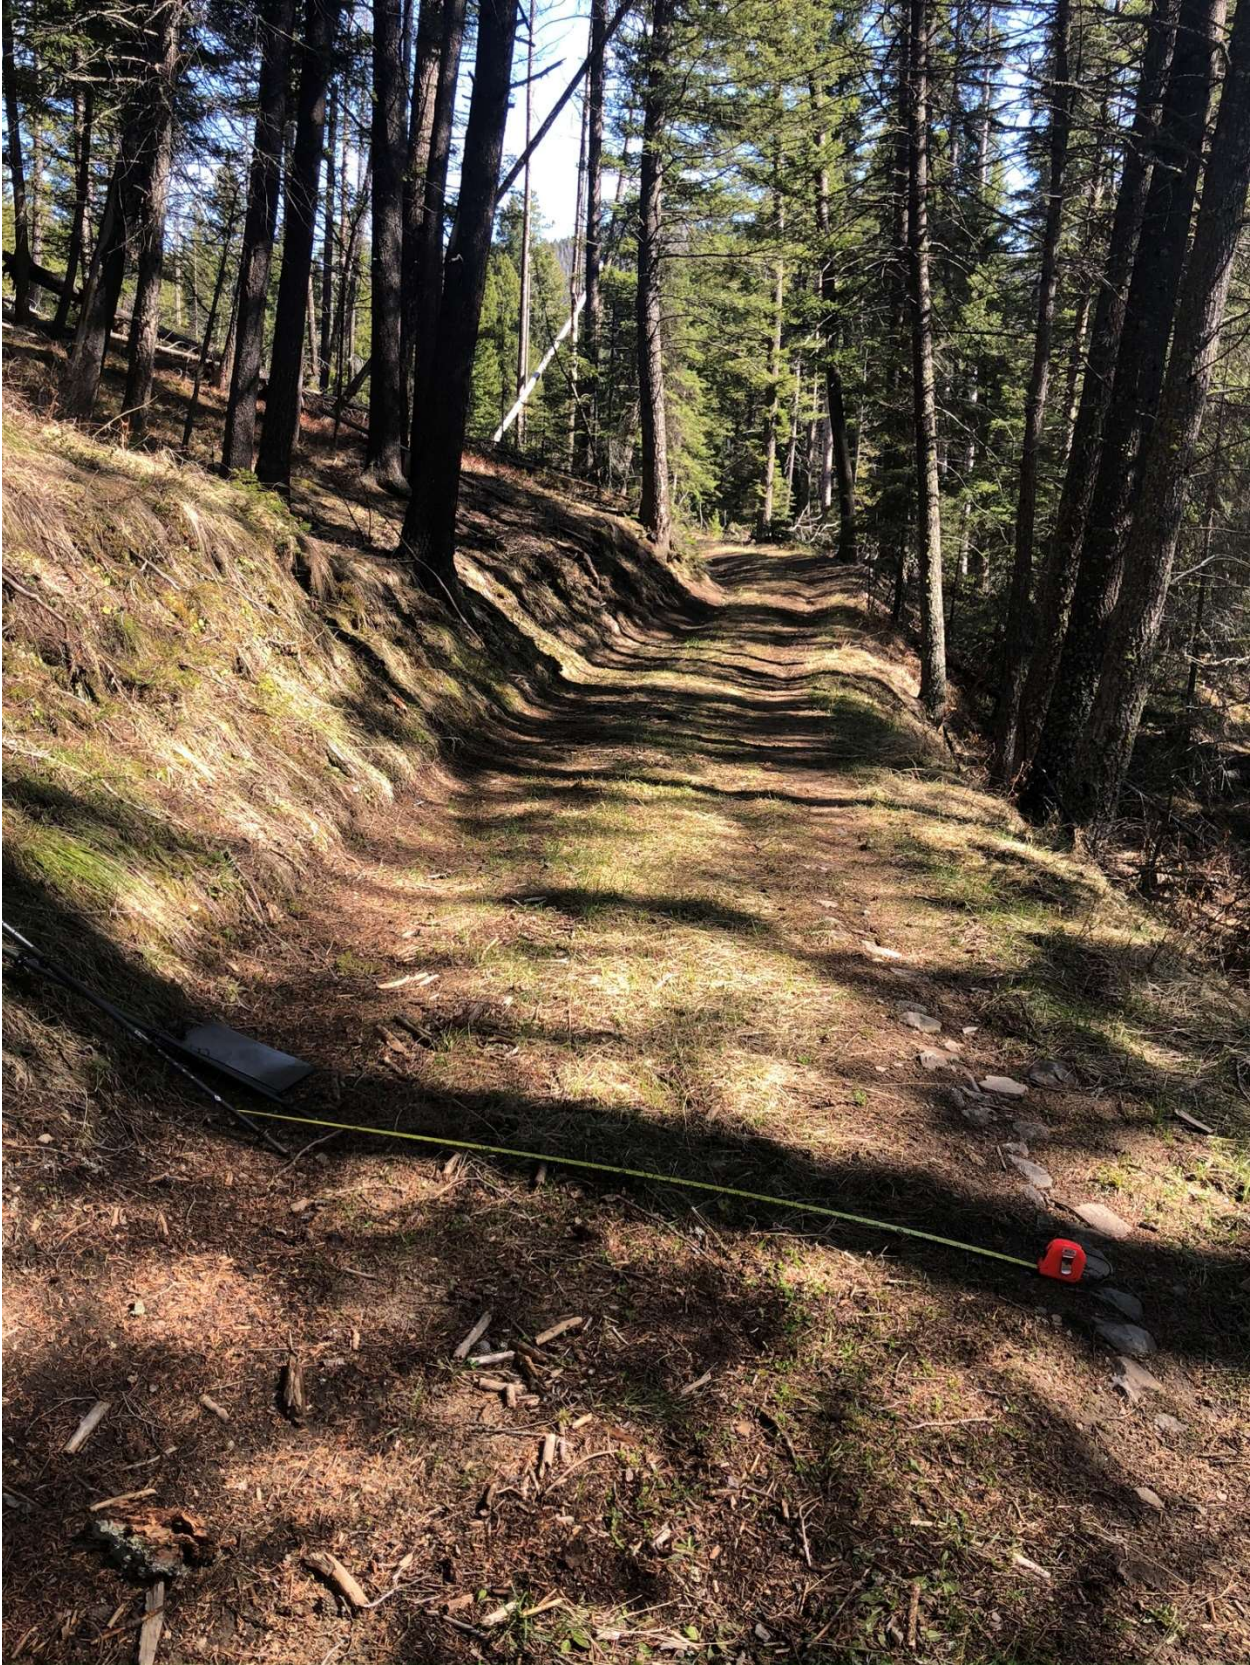
PHOTO NS01-3. 300 feet further up the road in the direction of travel. 7-8 foot roadbed.

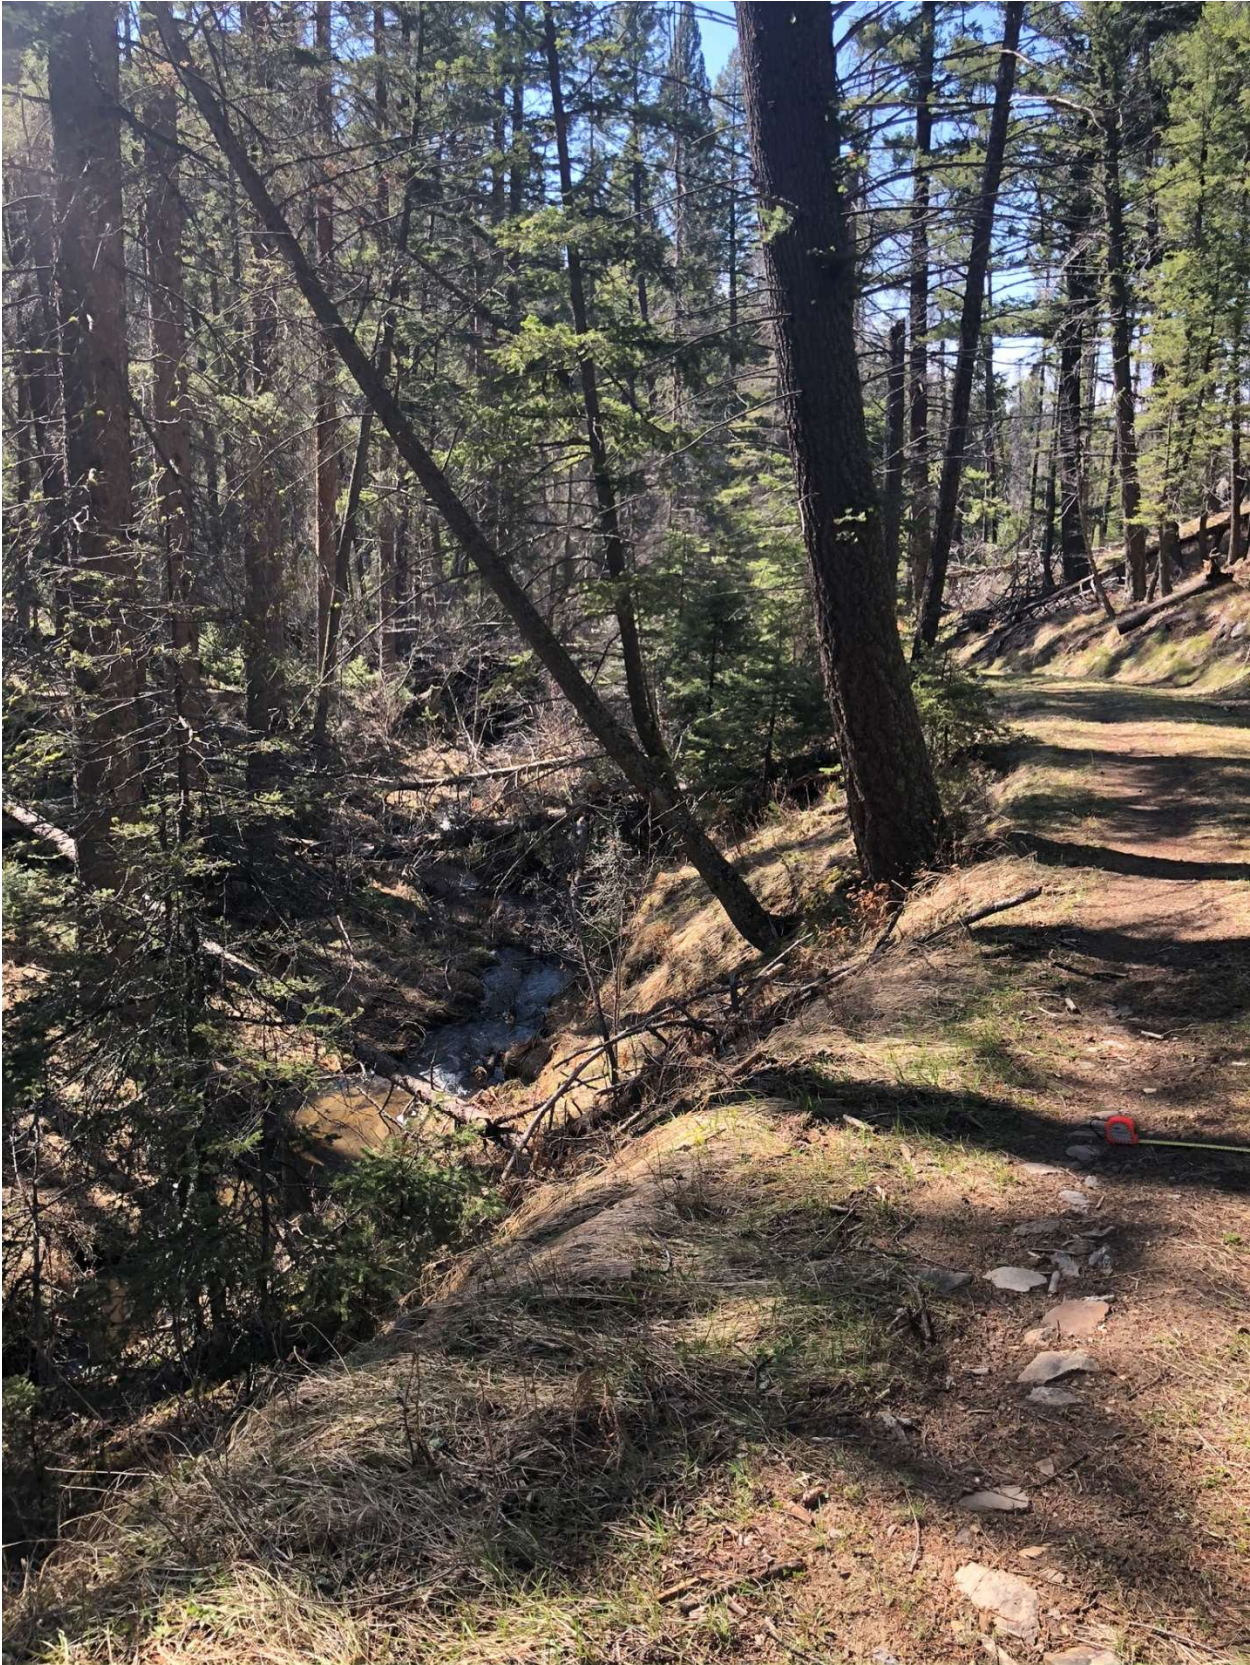
PHOTO NS01-5. Looking NW back down the road with Moose Creek visible below the road to the left.

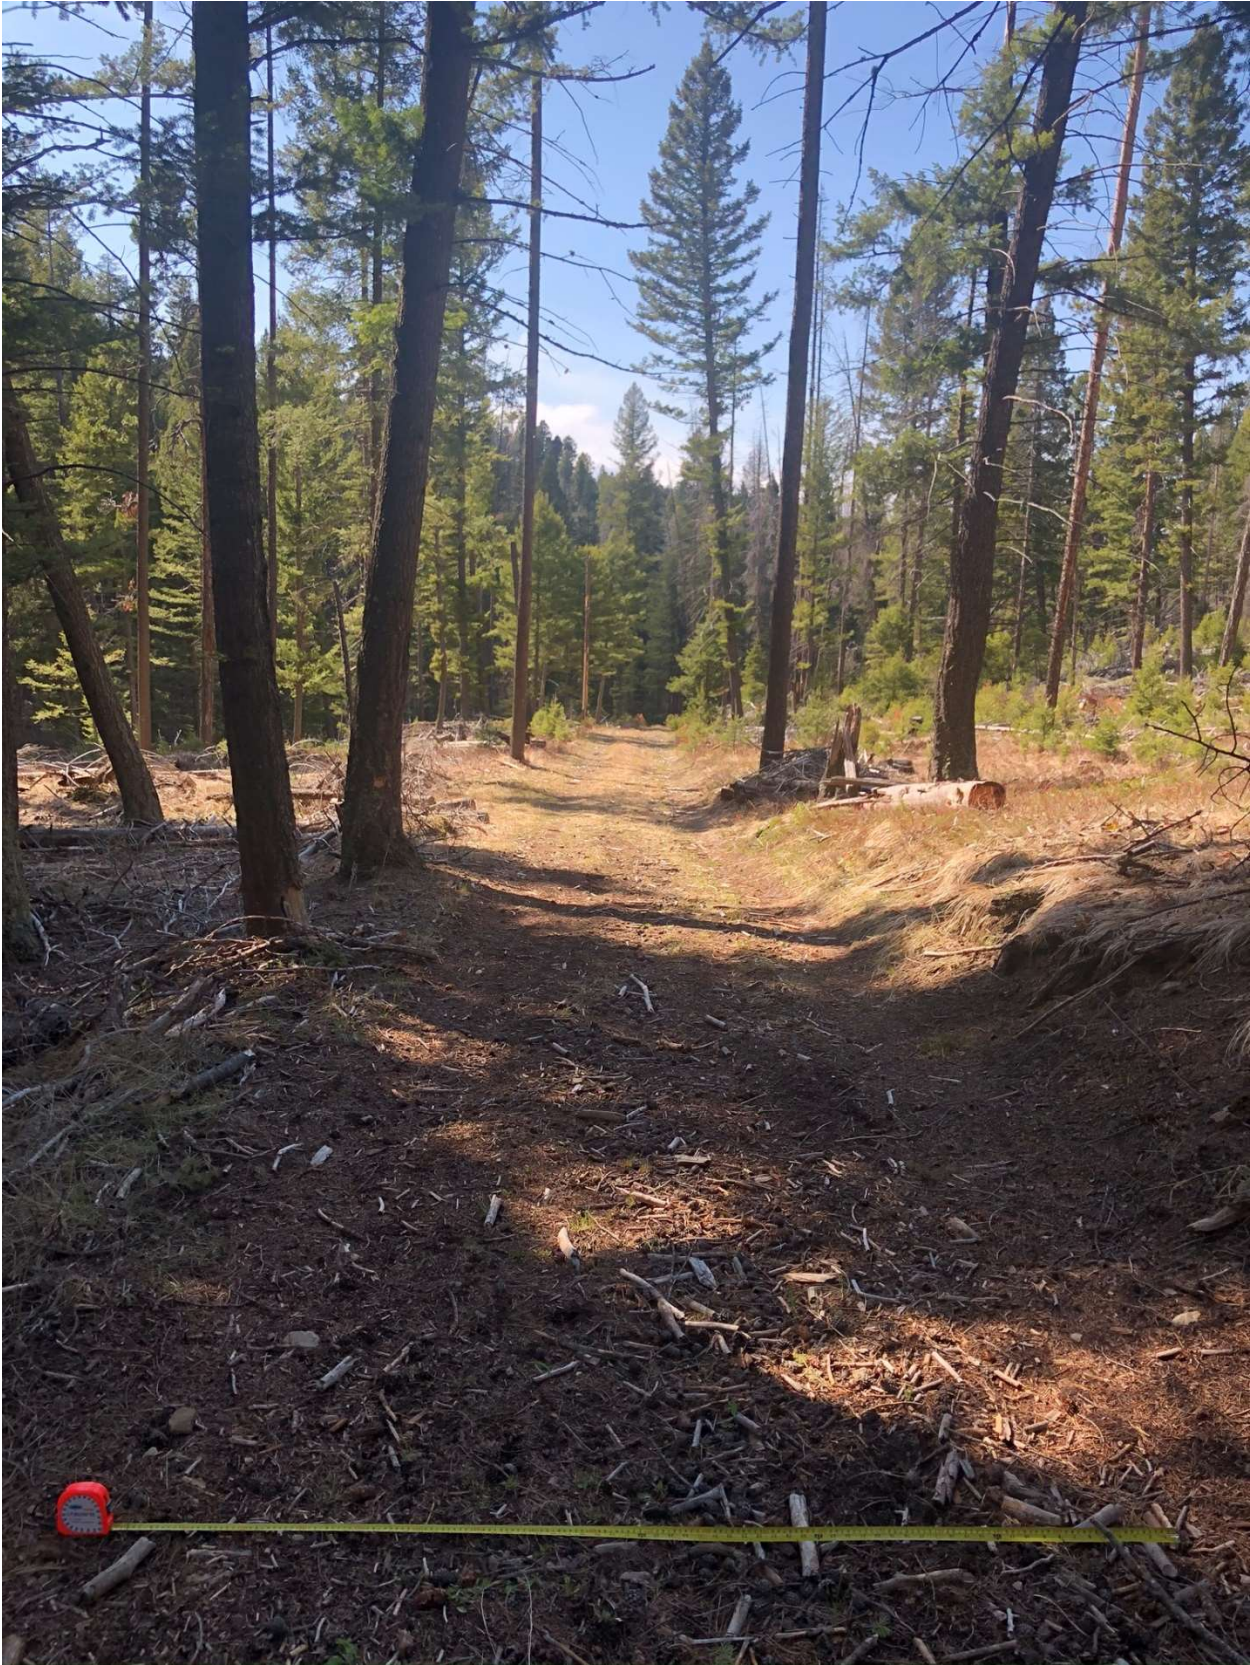
PHOTO NS01-7. Looking NW back down the Moose Creek Road. 6 foot tape measure.

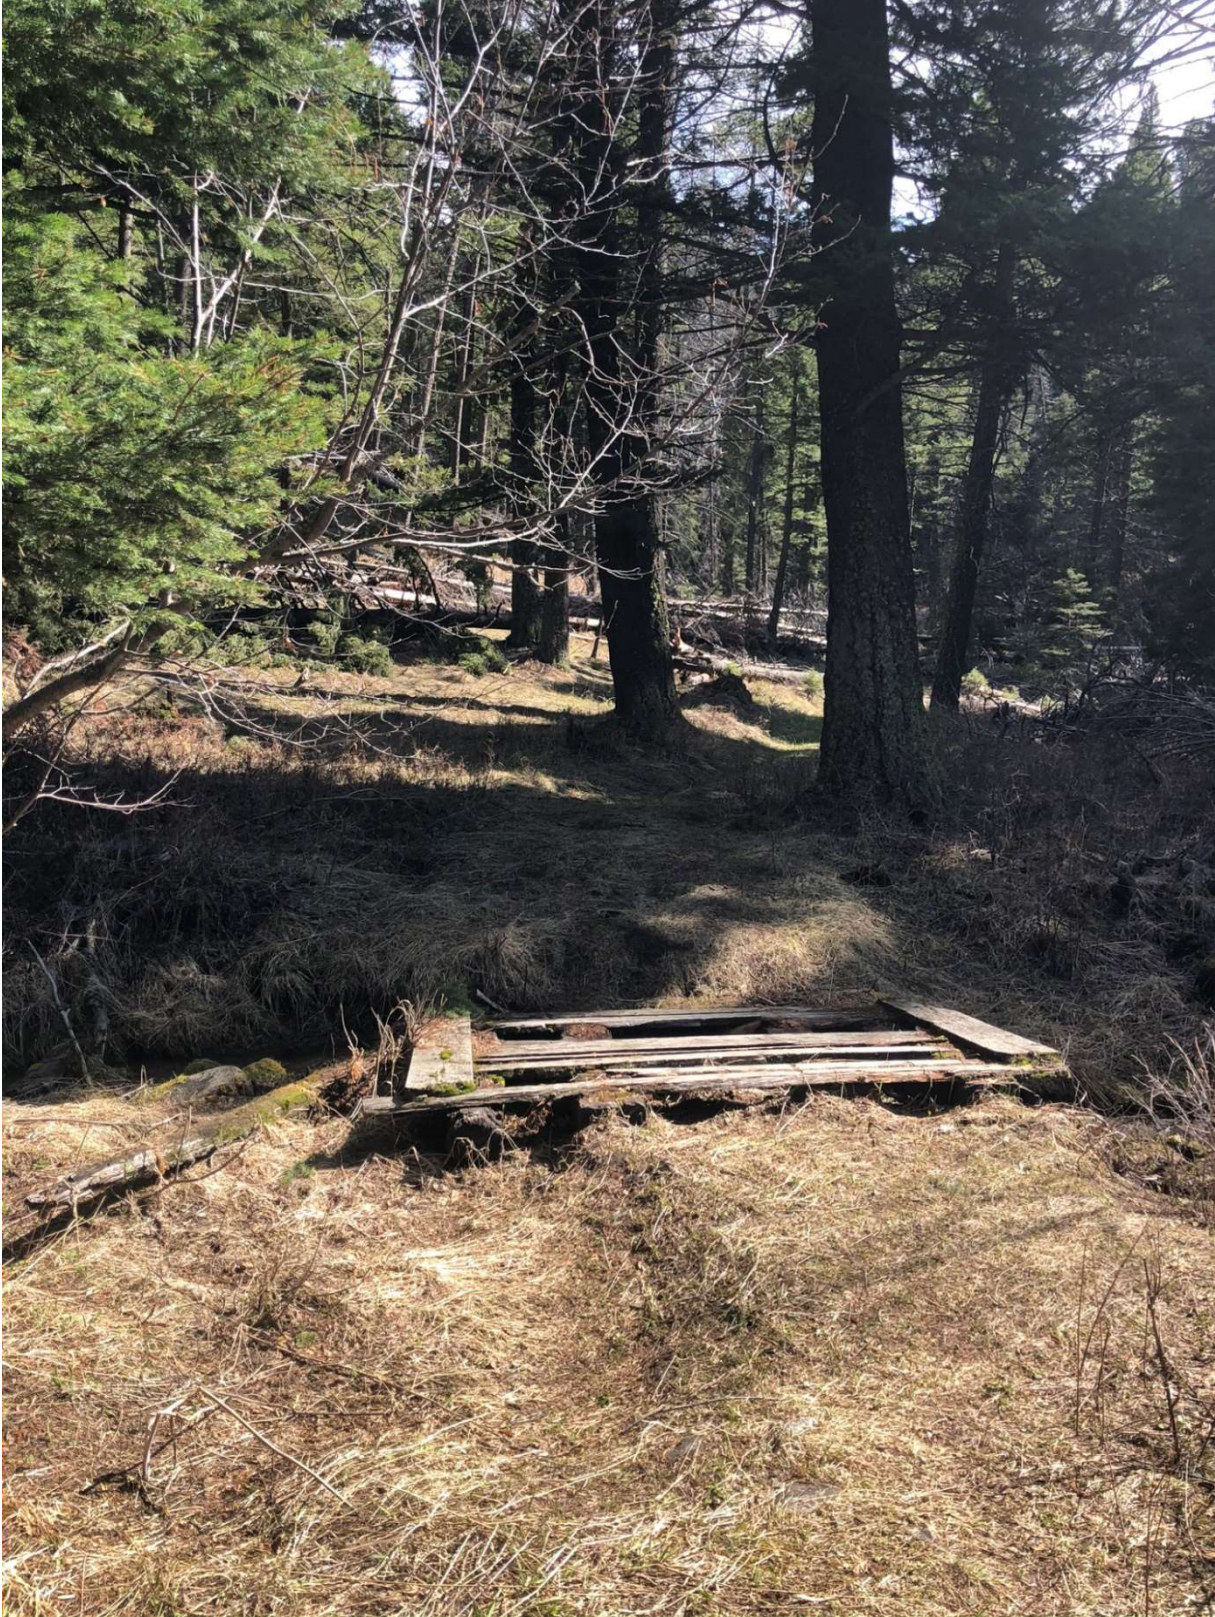
PHOTO NS01-8. Footbridge on the main road crossing a side tributary. Road narrowing to an ATV trail. Looking SE up the road.

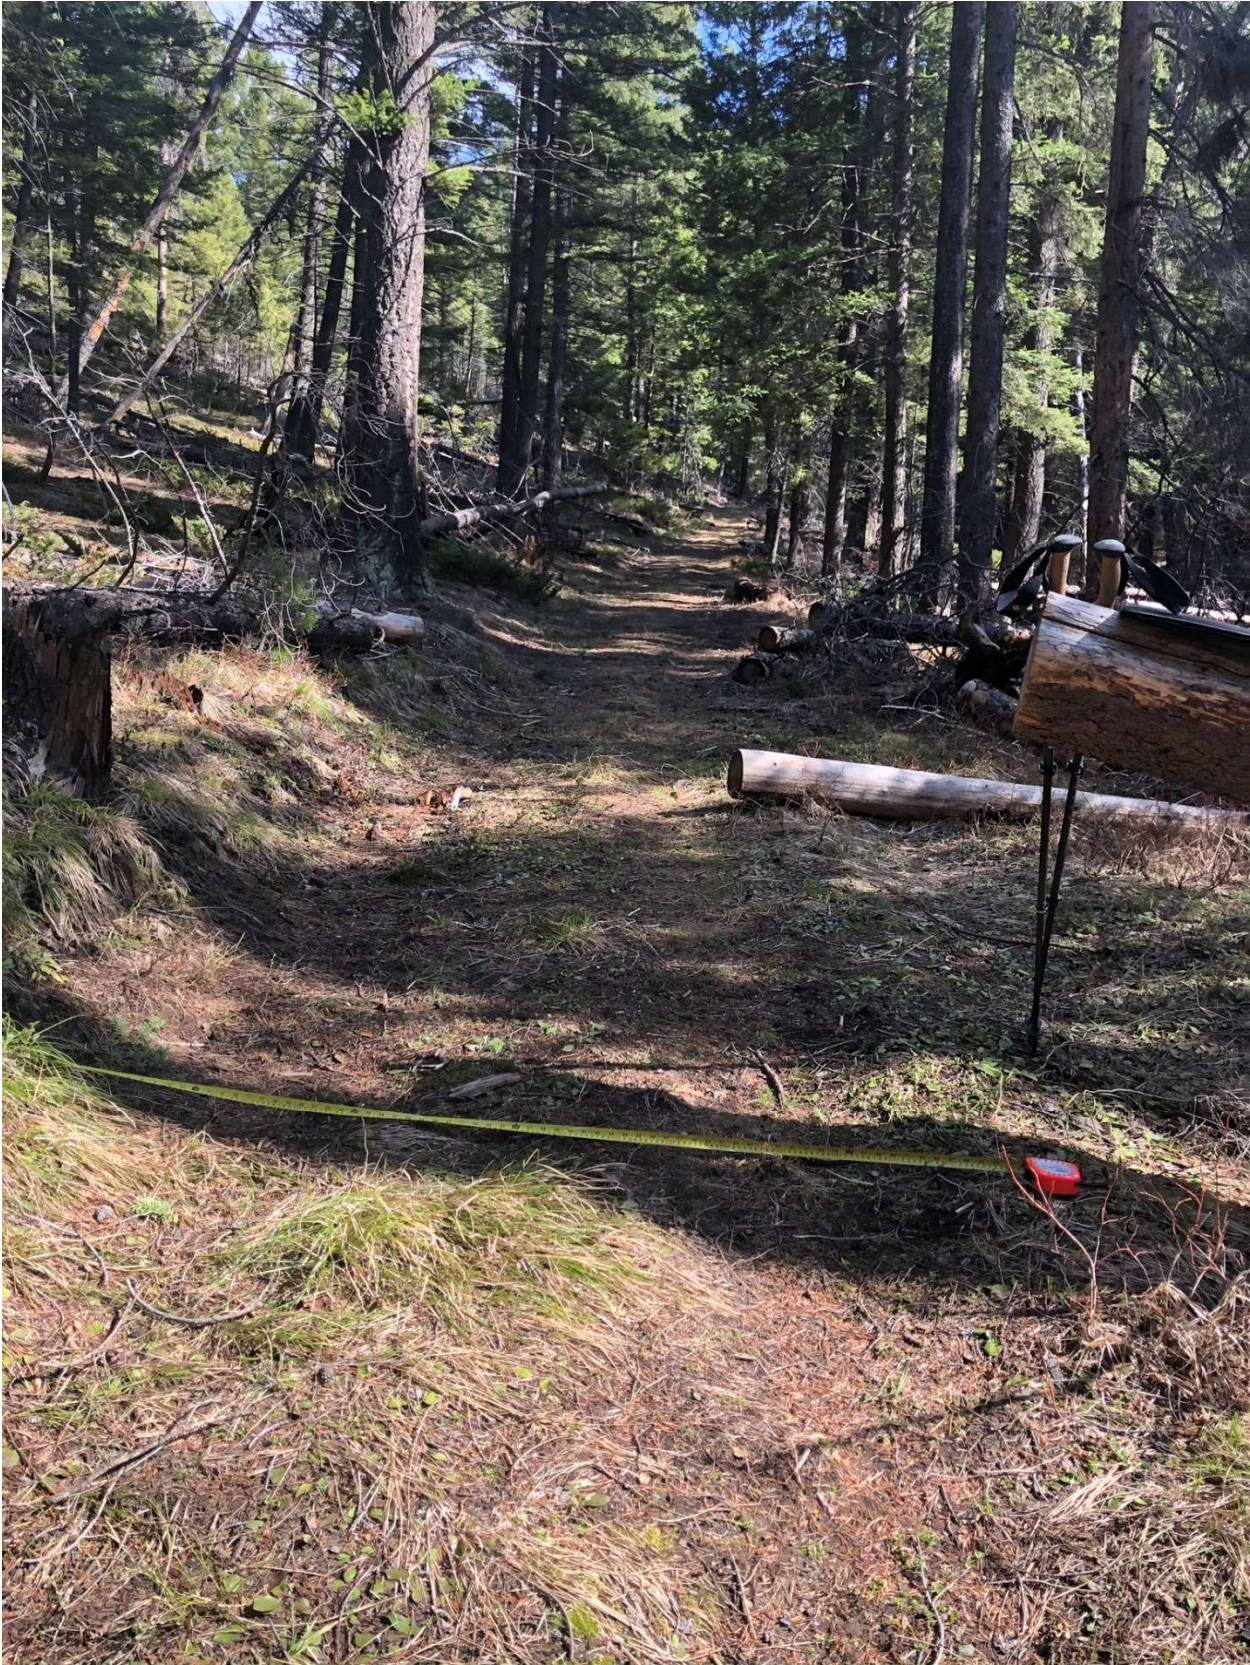
PHOTO NS01-11. Roadbed is about 6-7 feet wide. Evidence of routine trail clearing by ATV users.
