#1880-NS01, NS02, NS03 Moose Creek Waypoints MC-1 to MC-15
May 7, 2020

Road #1880 Segments NS01, NS02, NS03 in Moose Creek. Waypoints MC-1 to MC-15.

Screen-shot from Paper Maps™ mapping app of Moose Creek, Road #1880 in Lazyman Inventoried Roadless Area.

WAYPOINTS (#MC-1-MC-15) for 1880 Moose Creek May 7, 2020 – Gary Ingman

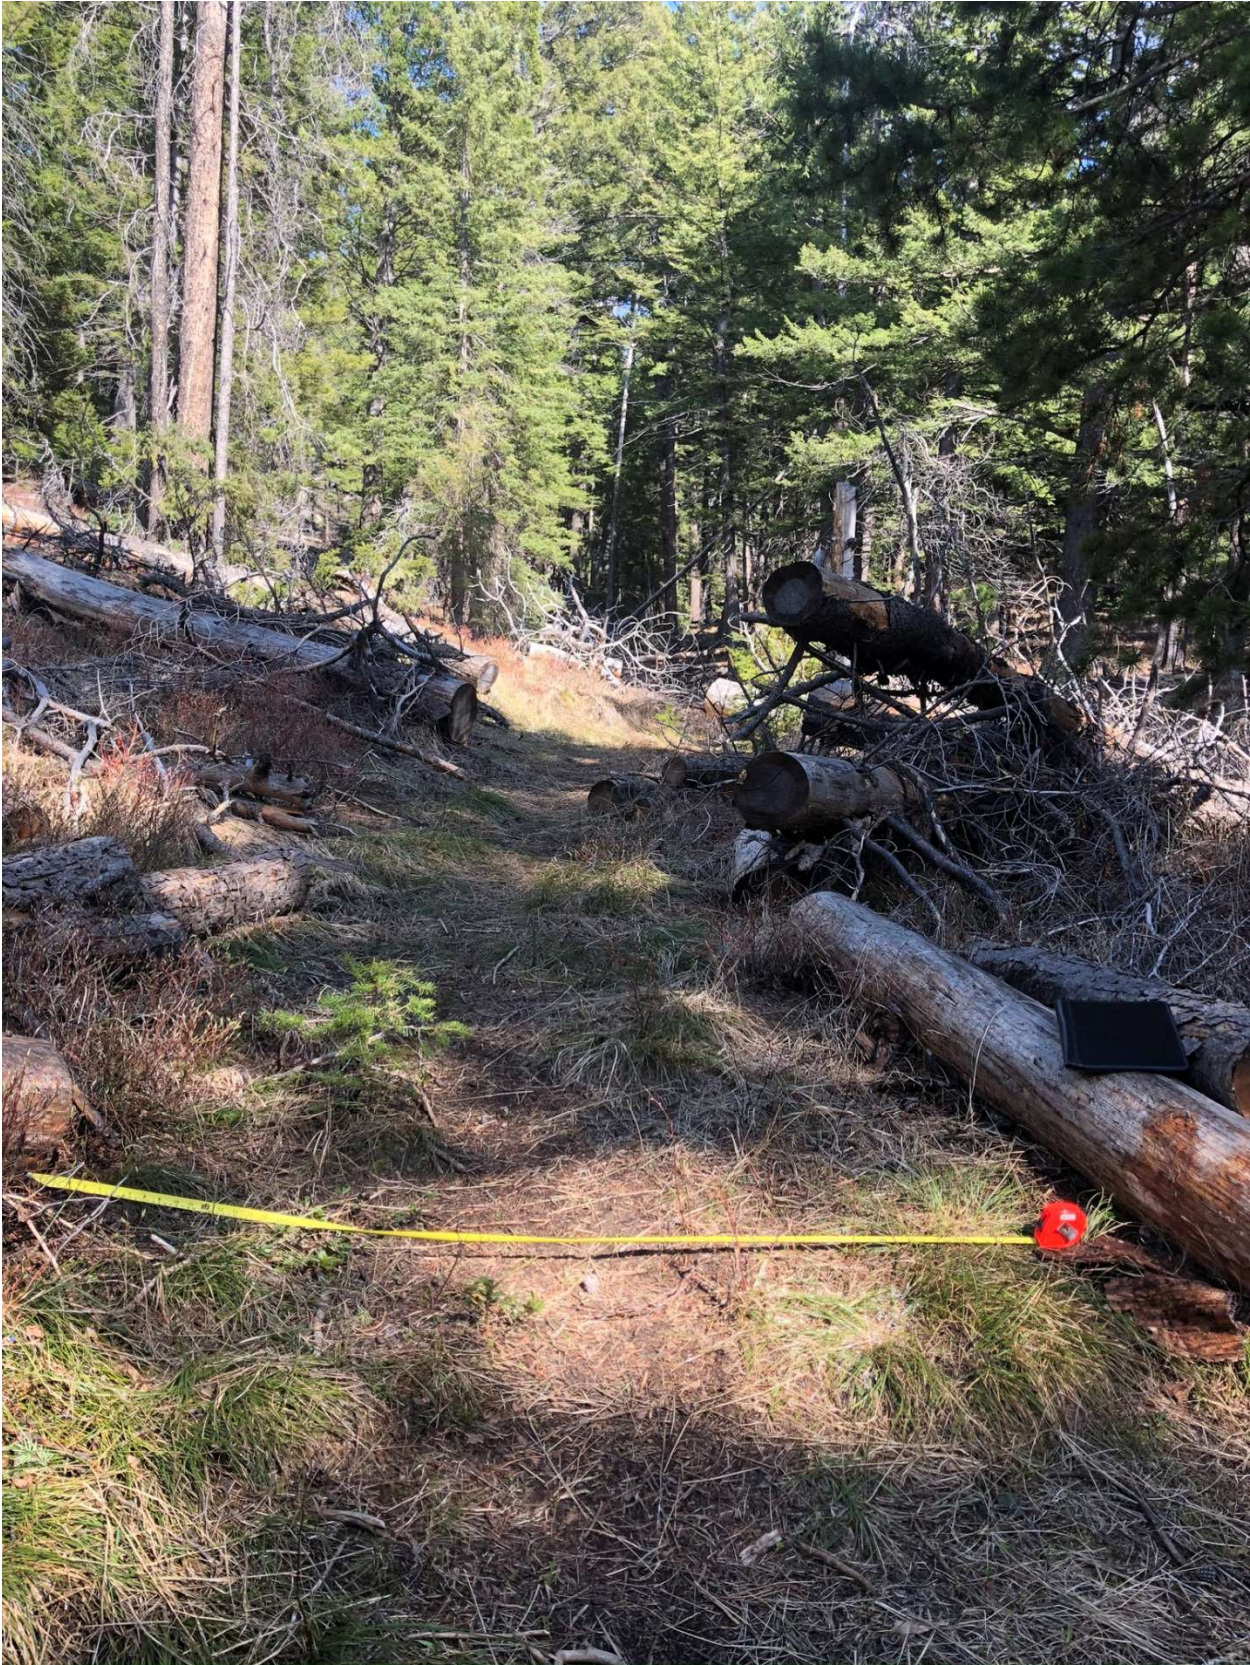
PHOTO NS01-15. Road continues to narrow. Increasingly mature D. fir forest. Evident trail clearing.

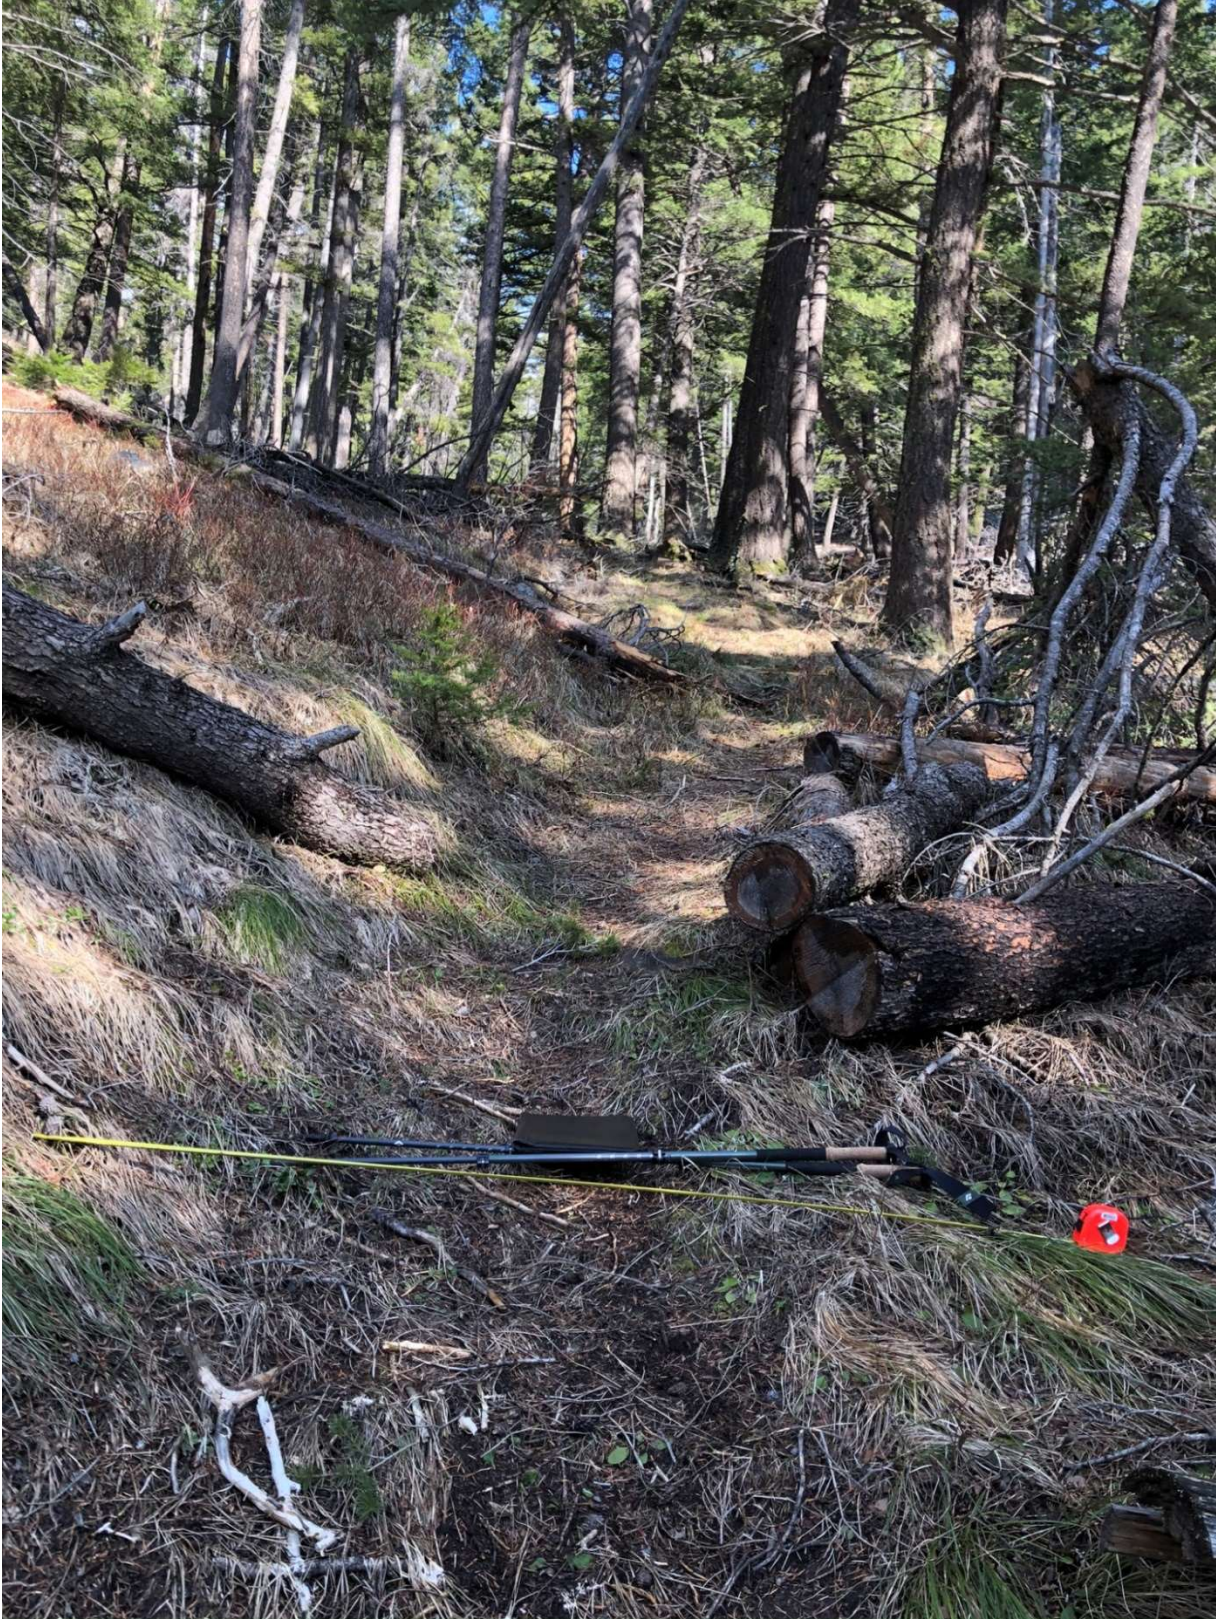
PHOTO NS01-19. Road turns into a horse or footpath at Waypoint MC-13. Looking up Moose Creek SE. Tape is at 6 feet.

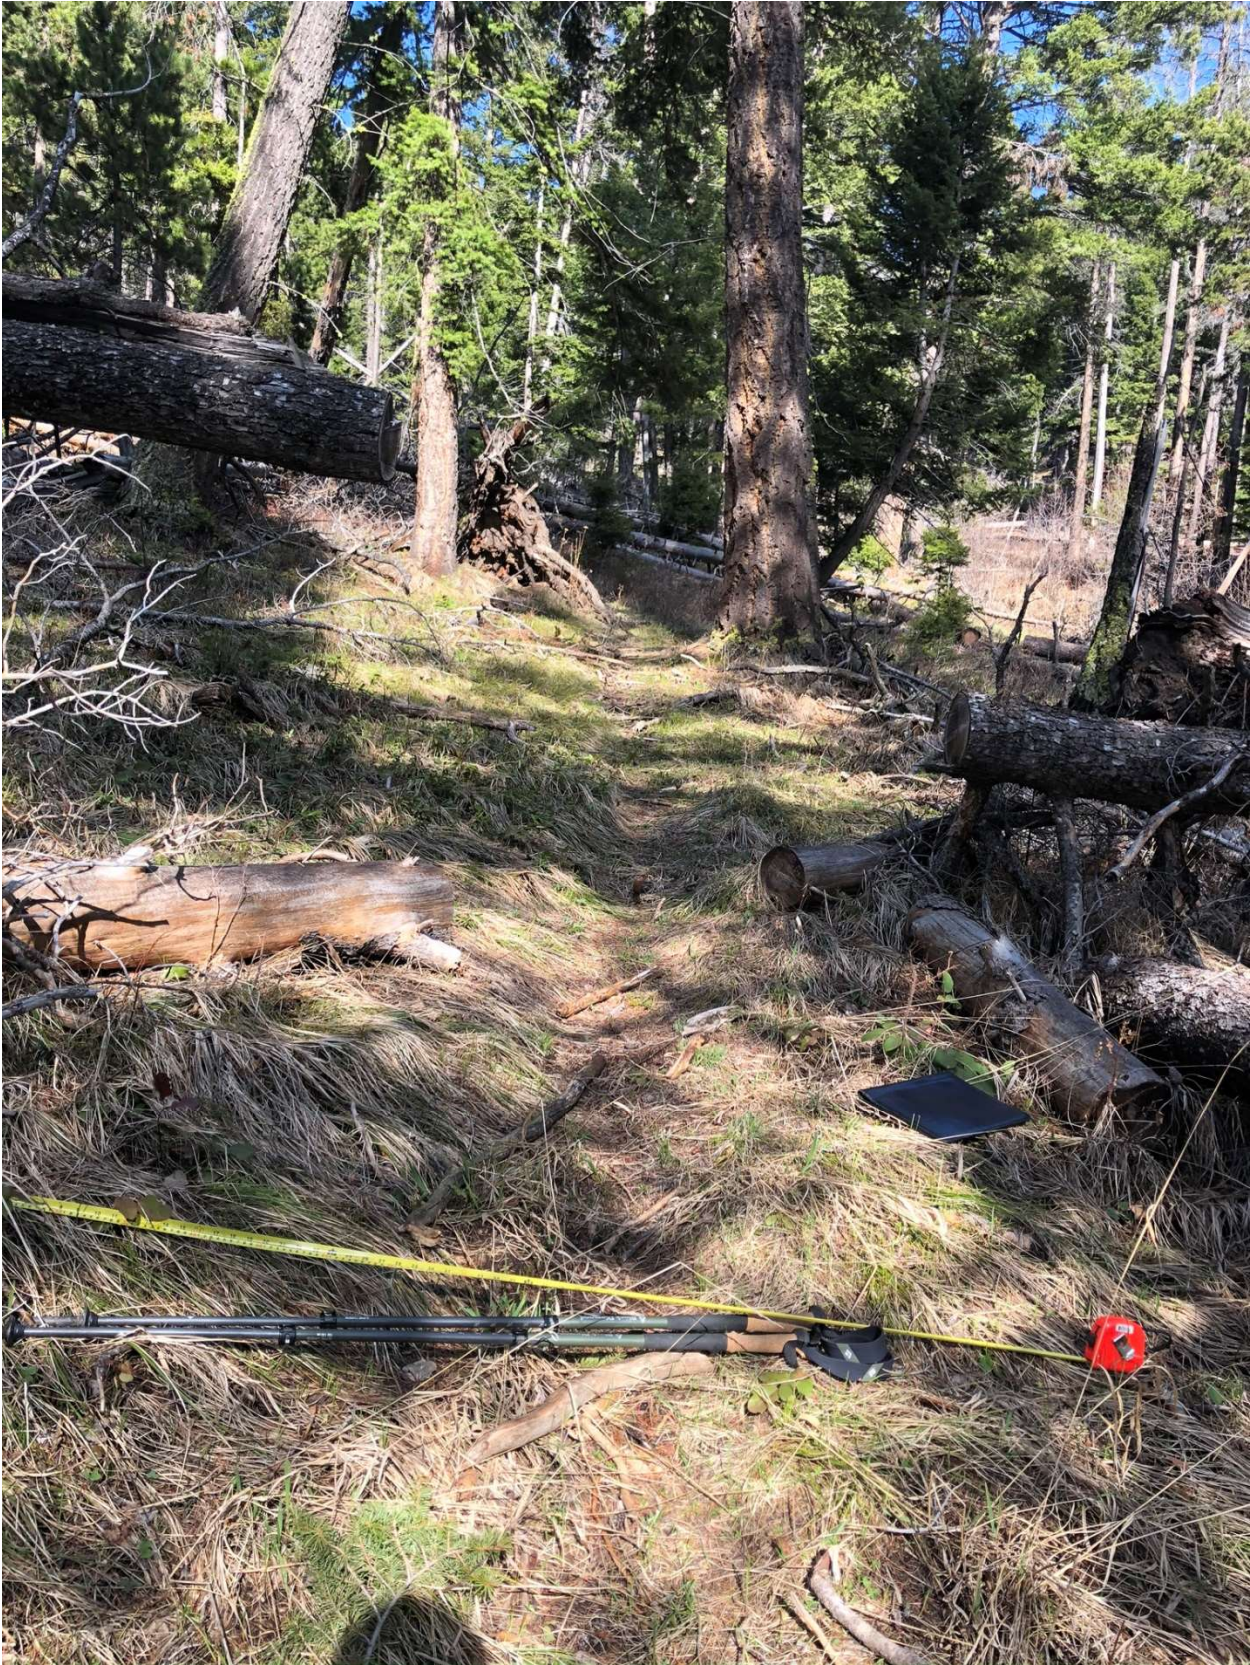
PHOTO NS01-21. Foot or horse path continues up the drainage with downfall sawn and cleared.

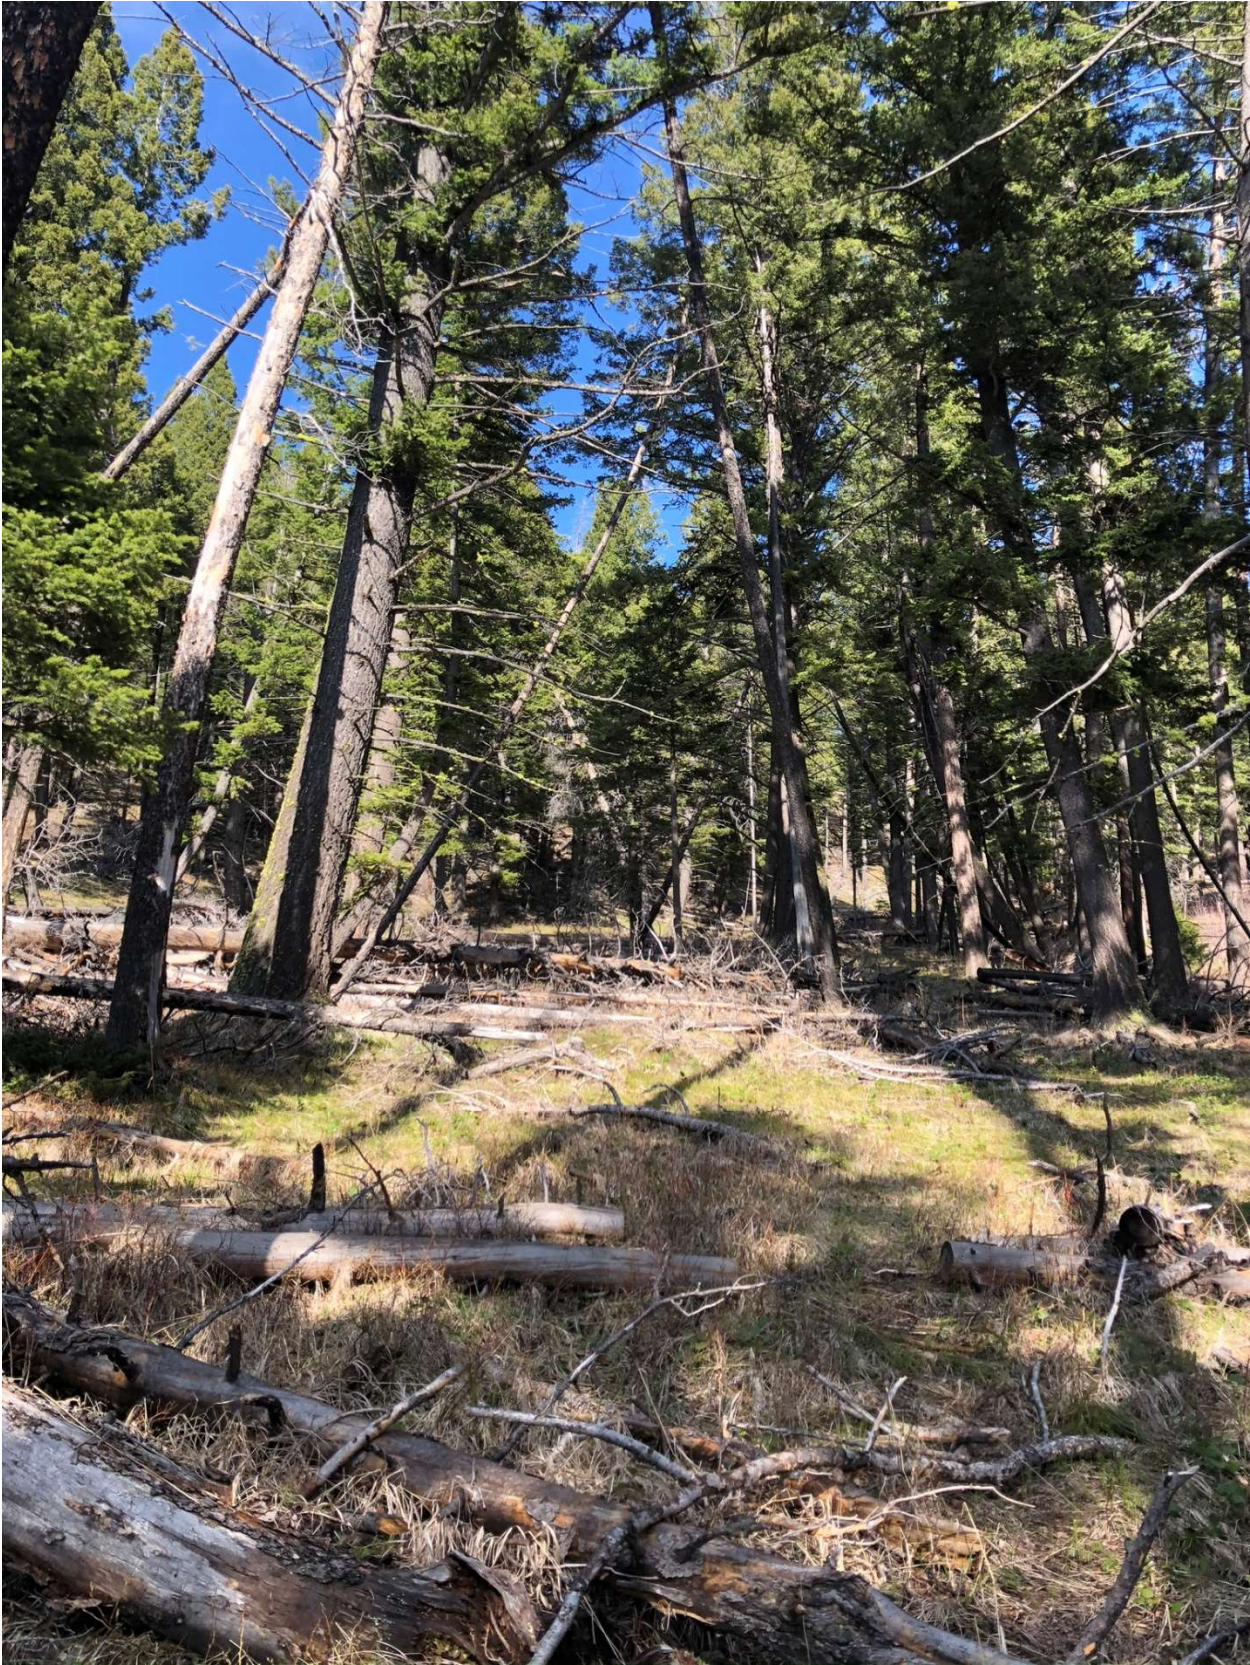
PHOTO NS01-23. At or past the end of NS01 showing hunter trail and no roadbed. Looking SE.

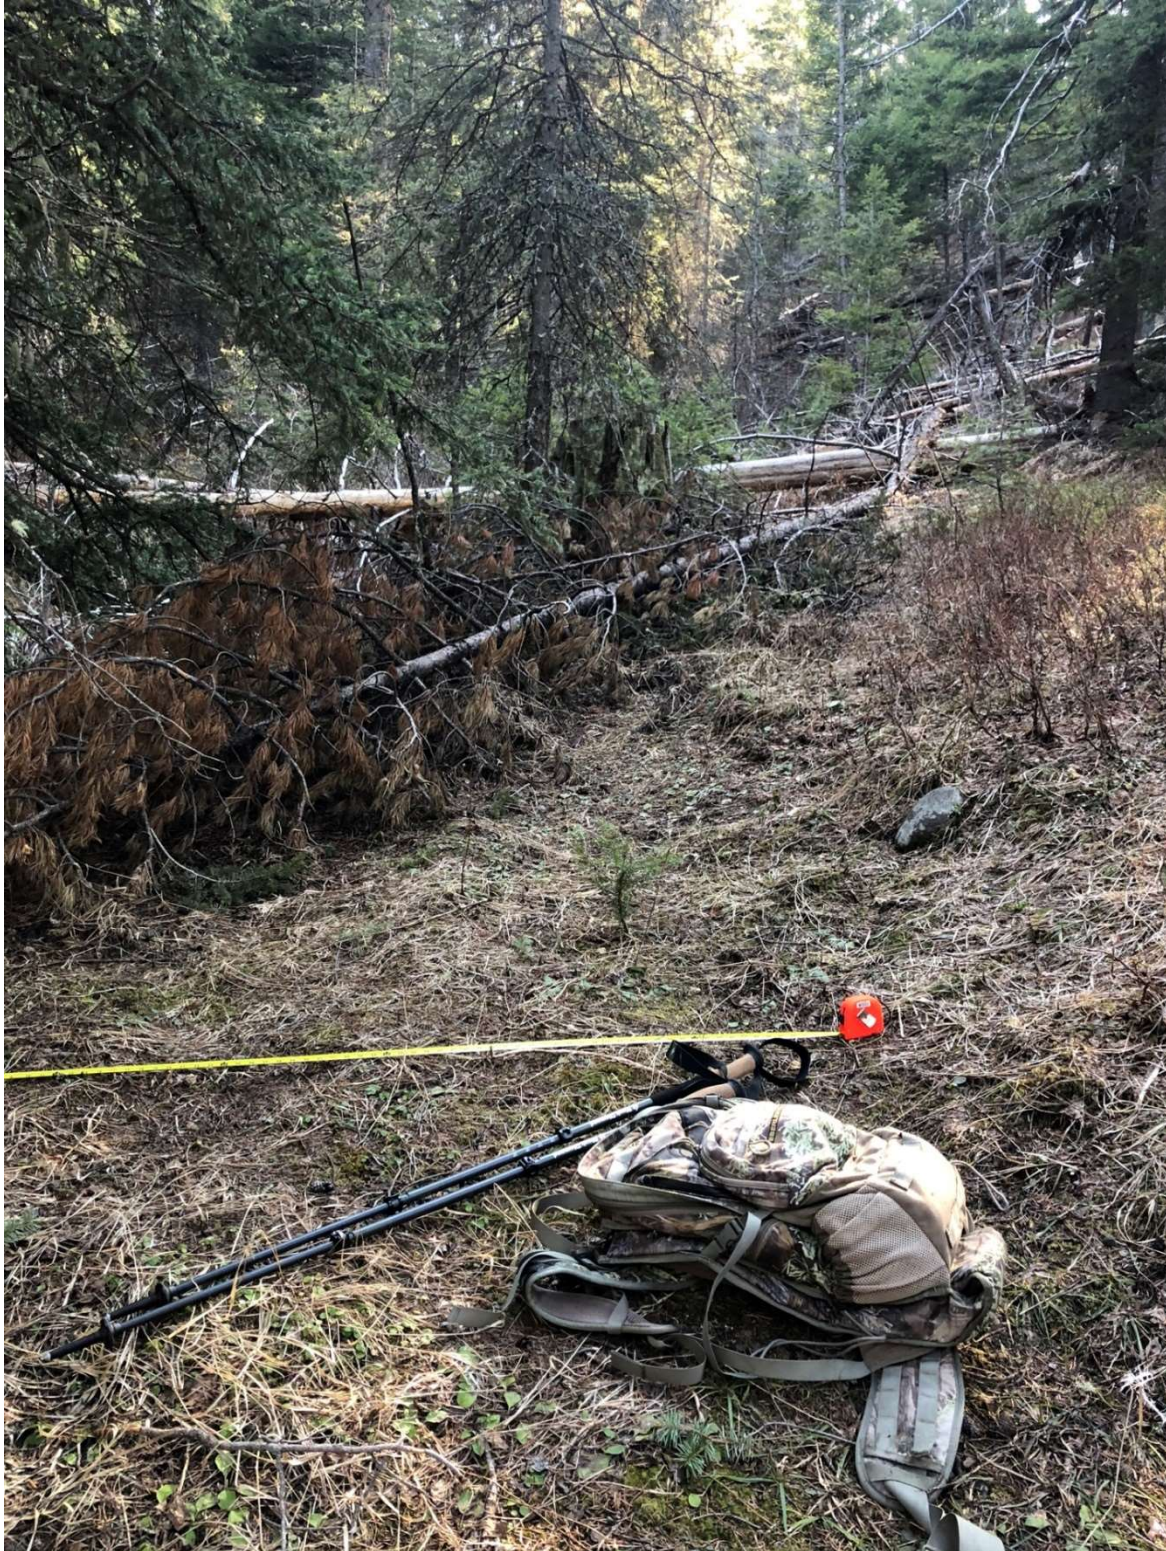
PHOTO NS02-1. Spur road NS02 from its lower end near Moose Creek looking S. 6-8 foot roadbed covered with extensive blowdown. Tributary creek on the left, looking upstream.

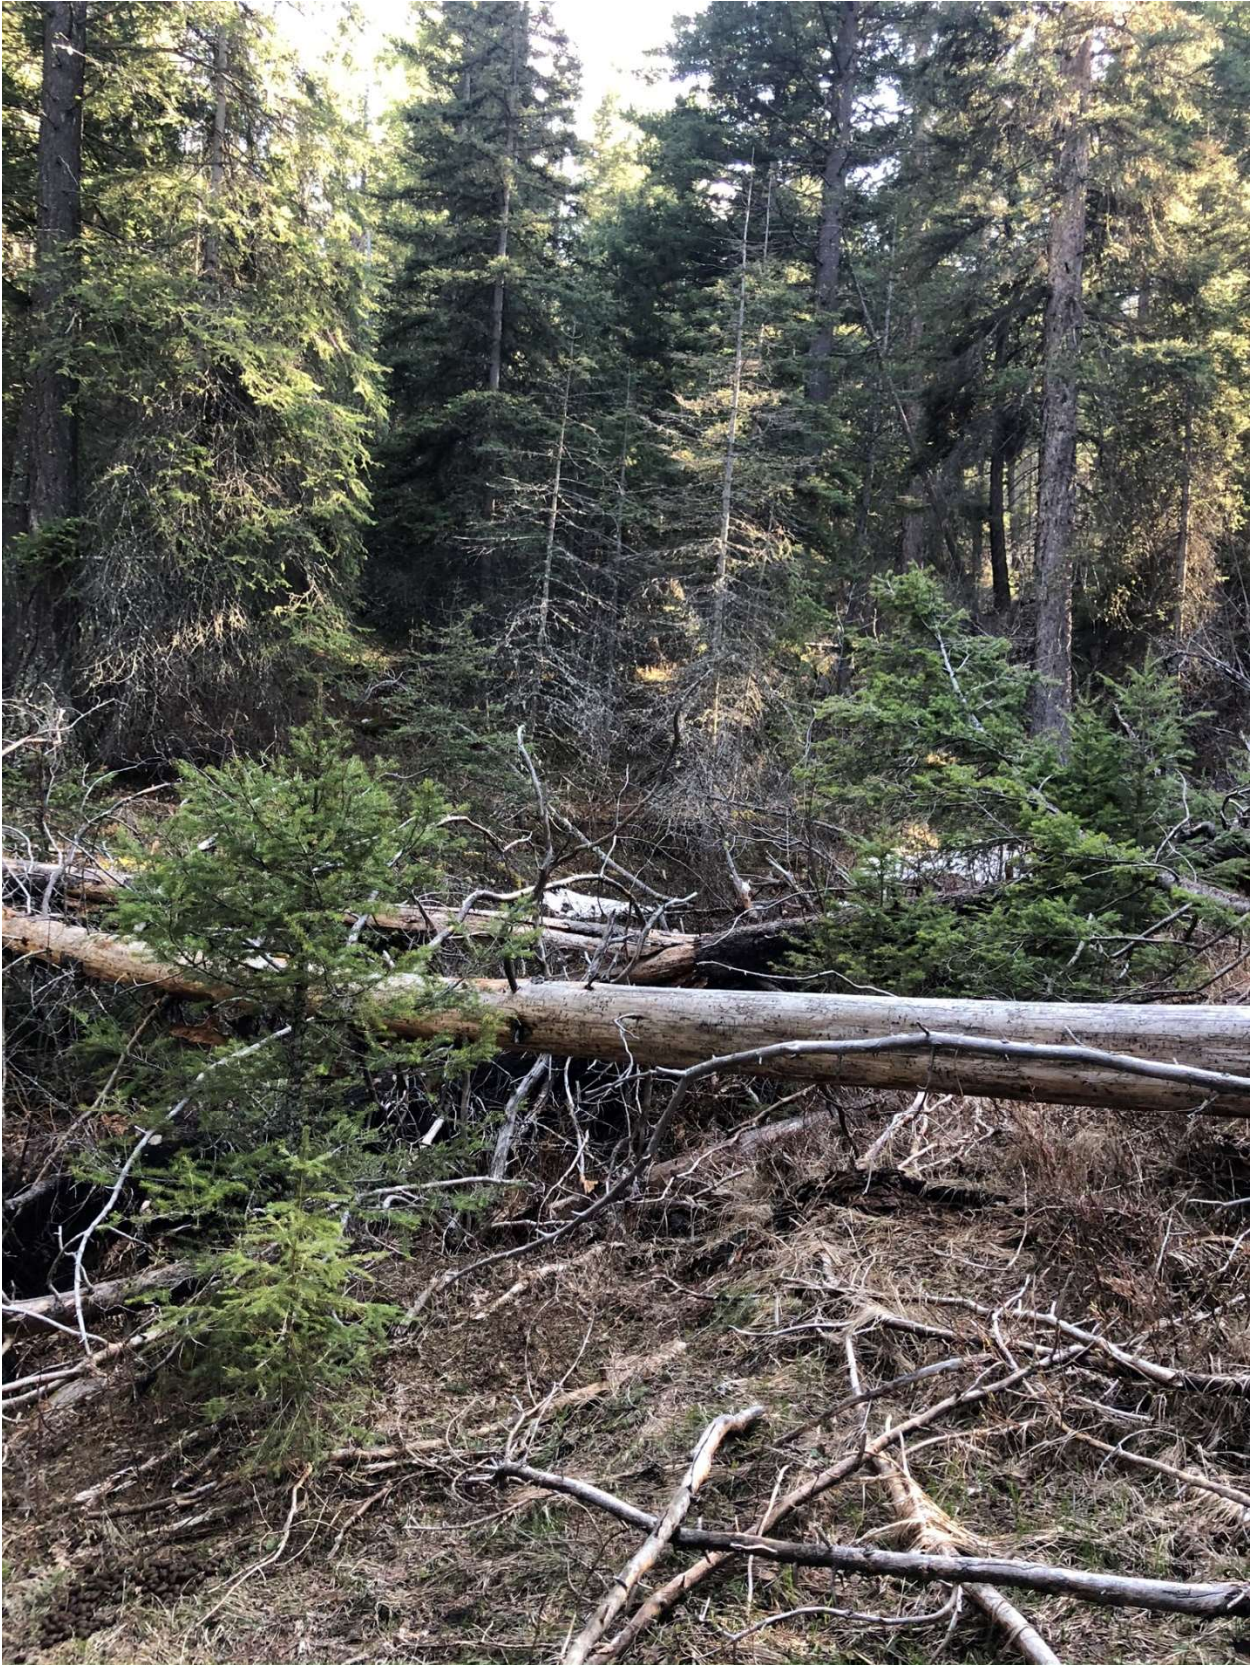
PHOTO NS02-3. Approximately 300 feet further up the road. Inundated by blowdown.

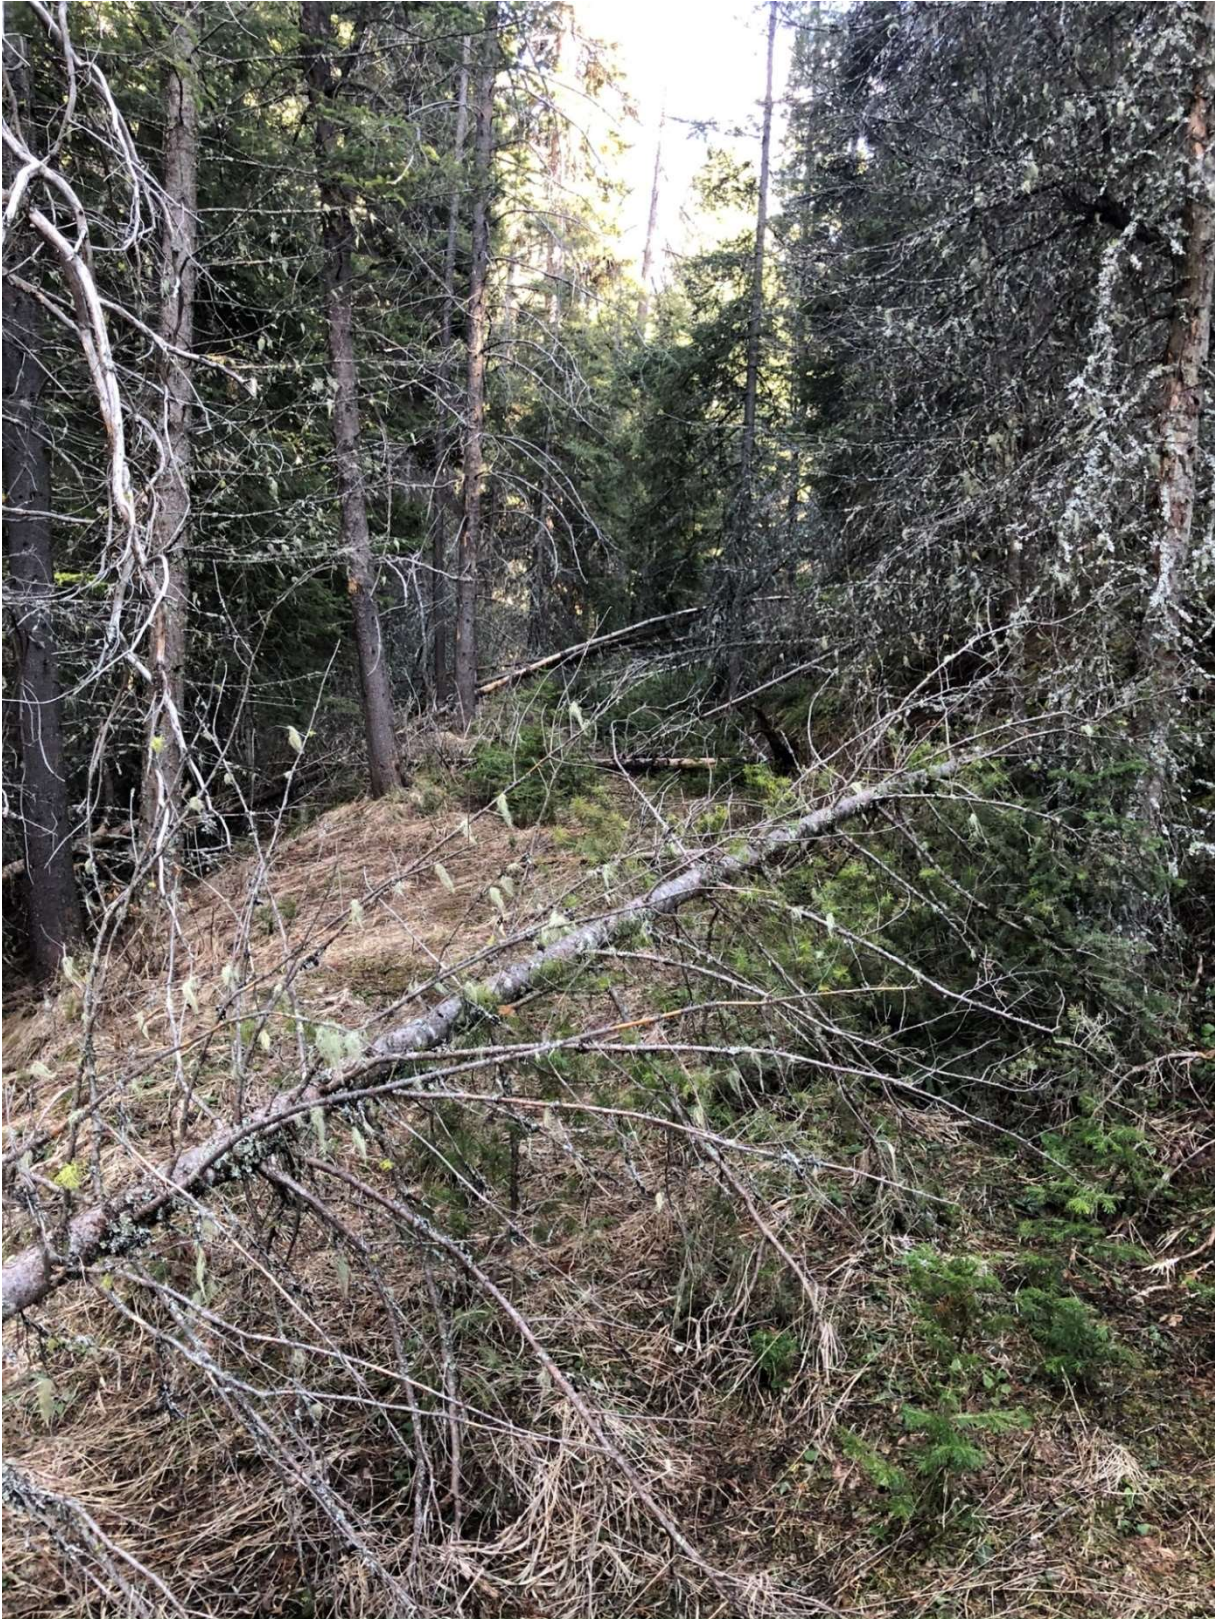
PHOTO NS02-5. NS02 where it parallels Moose Creek. Looking NW with main Moose Creek to the left of the photo.
