## #299-NS05, 299-C1, 299-U001 (Beaver Creek)

## SURVEY OF #299 Series Roads

Waypoints 012 – 016 (#299-NS05), 017 – 019 (#299-C1), 020 – 022 (#299-U001)

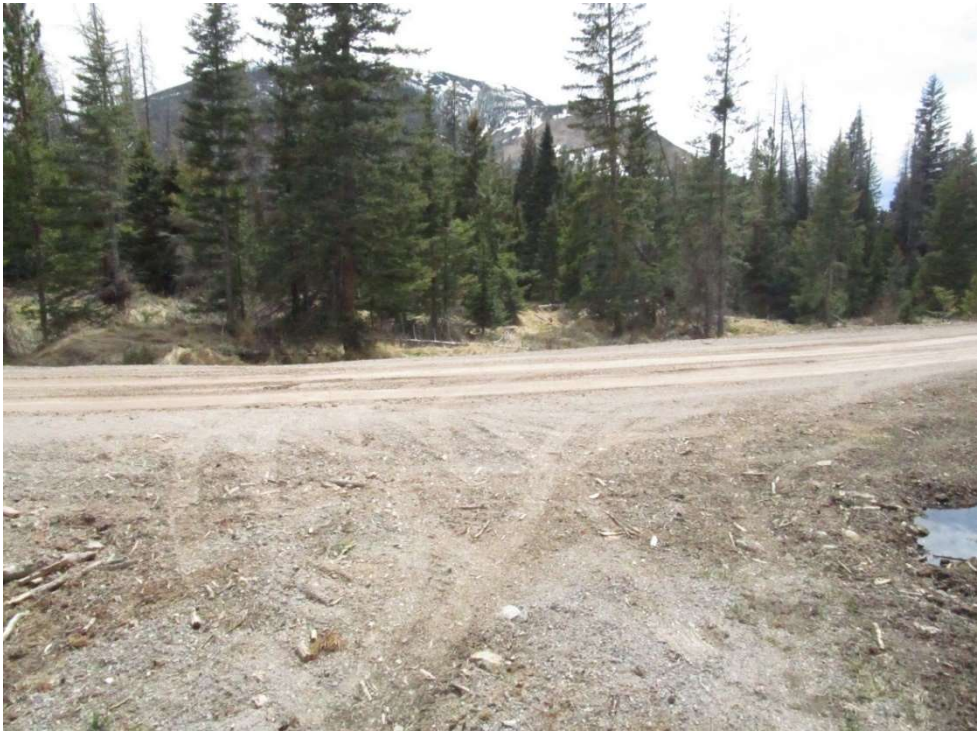
WAYPOINT 012 – Junction of Chessman road and #299-NS05. SW photo direction.

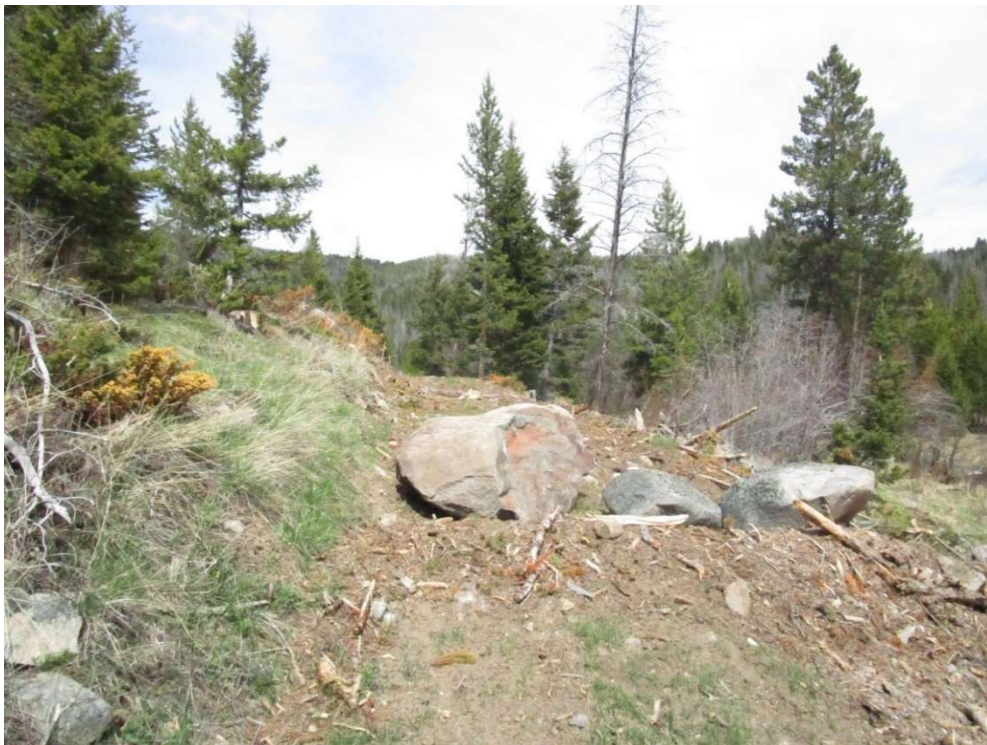
WAYPOINT 012 – Start of 299-NS05. Large rock road blocks used. Road development with woody debris due to recent timber harvest, NE photo direction.

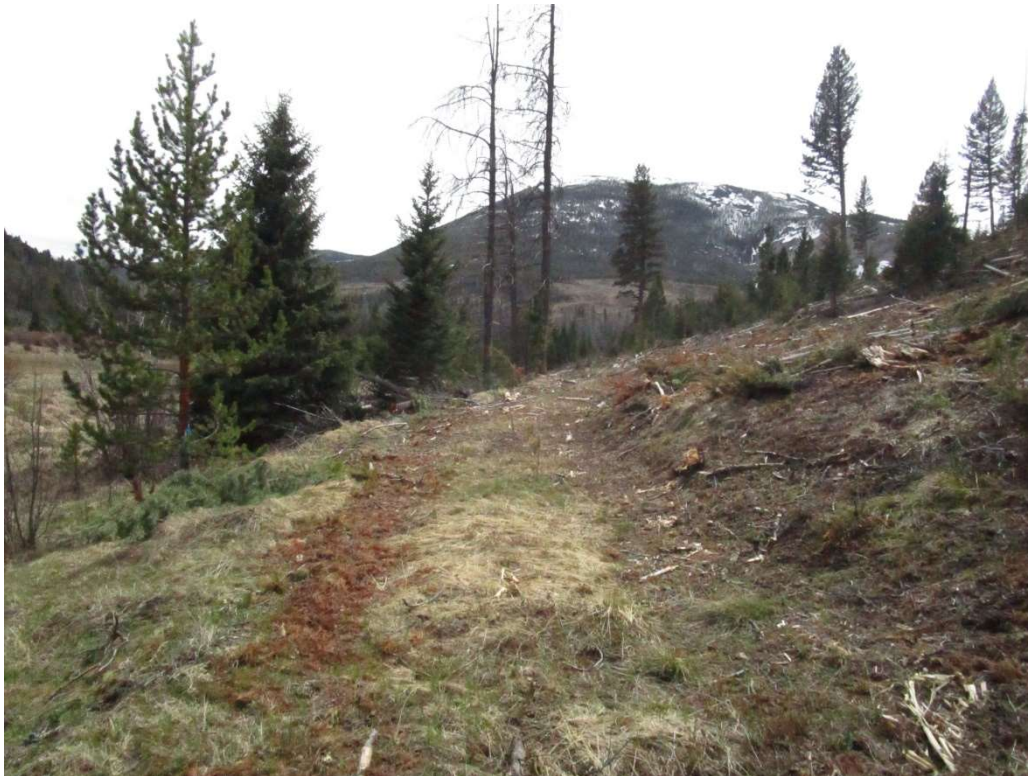
WAYPOINT 013 – Road used for recent timber harvest on right, south photo direction, 15 foot road width.

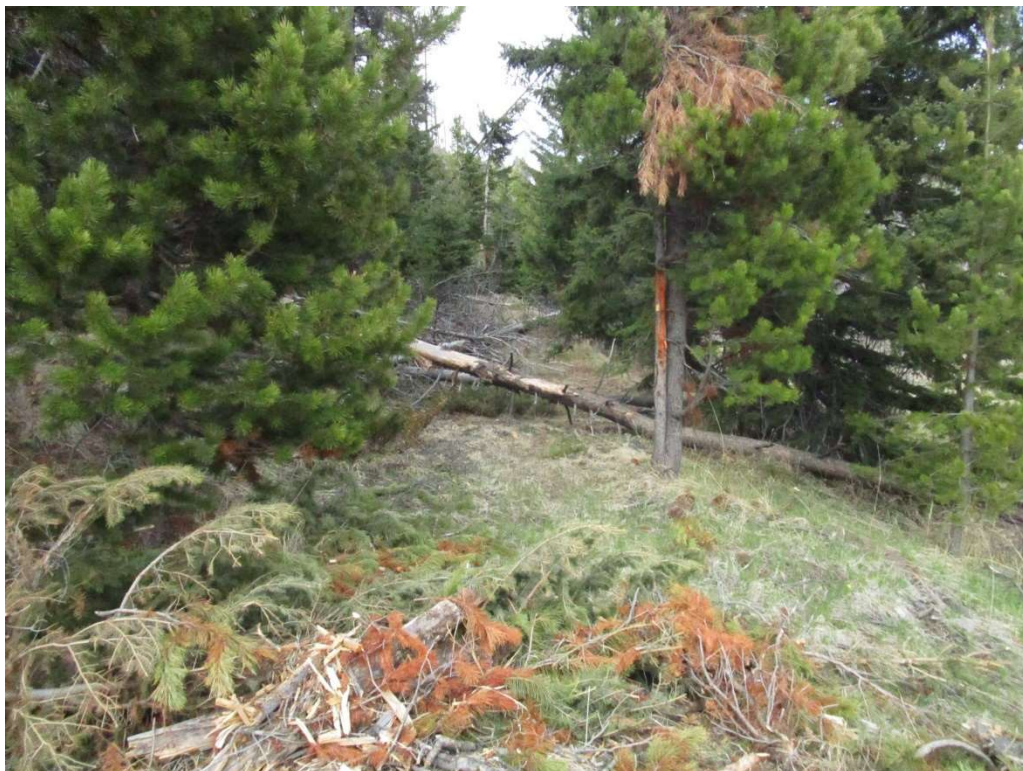
WAYPOINT 013 – Boundary of Tenmile IRA indicated by marked trees and blocked by downed trees, north photo direction.

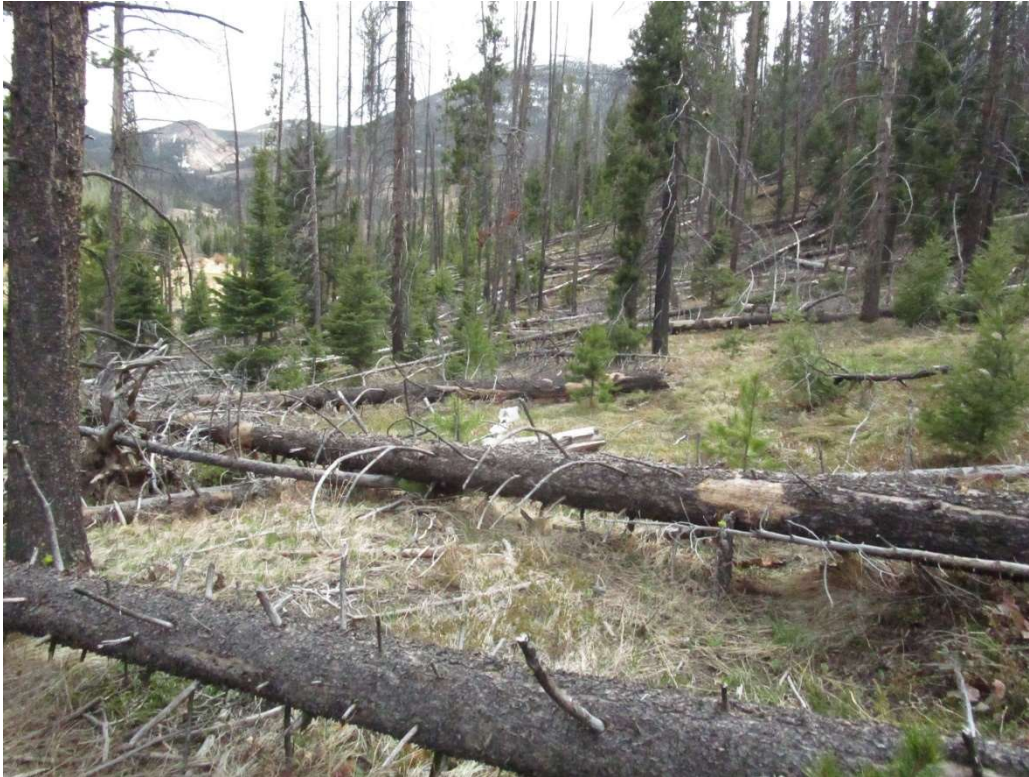
WAYPOINT 014 – Road bed barely distinguishable due to wind-blown deadfall and lodgepole pine regeneration and herbaceous undergrowth, south photo direction.

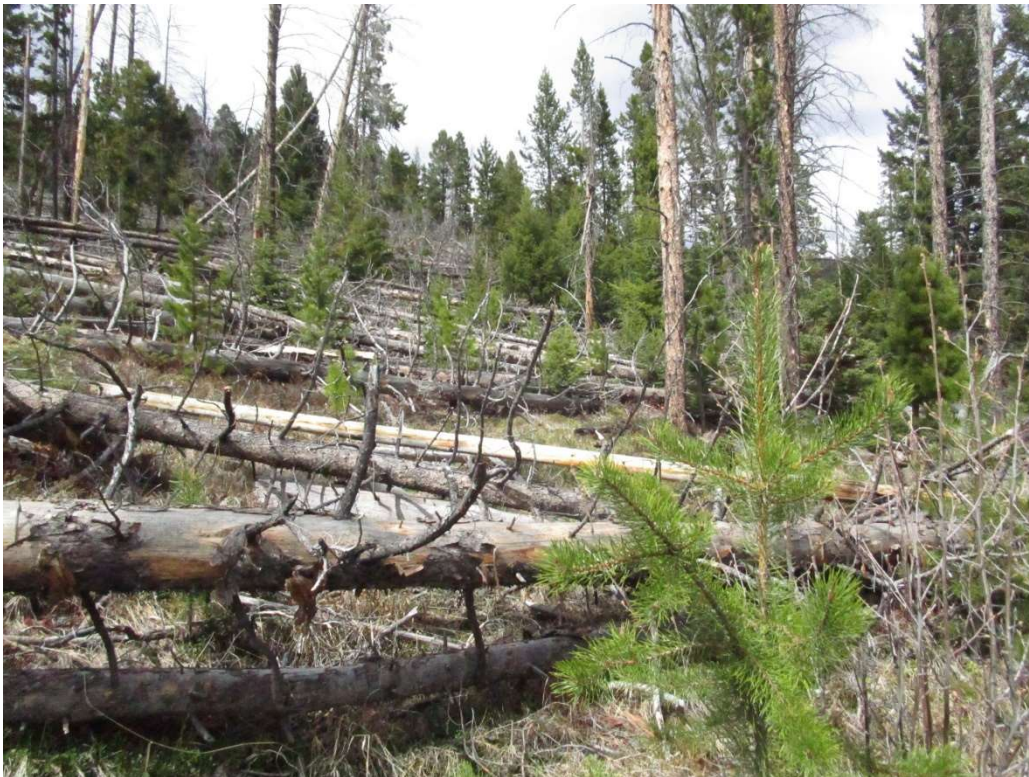
WAYPOINT 014 – Road bed barely distinguishable due to wind-blown deadfall and lodgepole pine regeneration and herbaceous undergrowth, north photo direction.

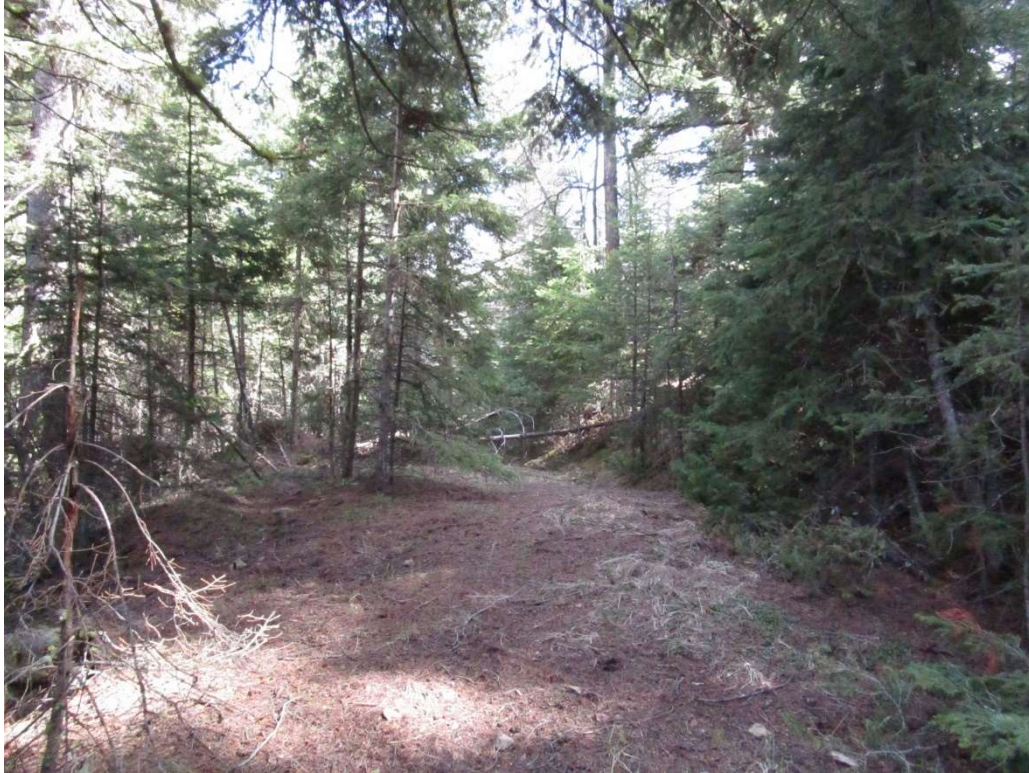
WAYPOINT 015 – Old road bed about 12 feet wide, some conifer seedling/sapling regeneration, SE photo direction.

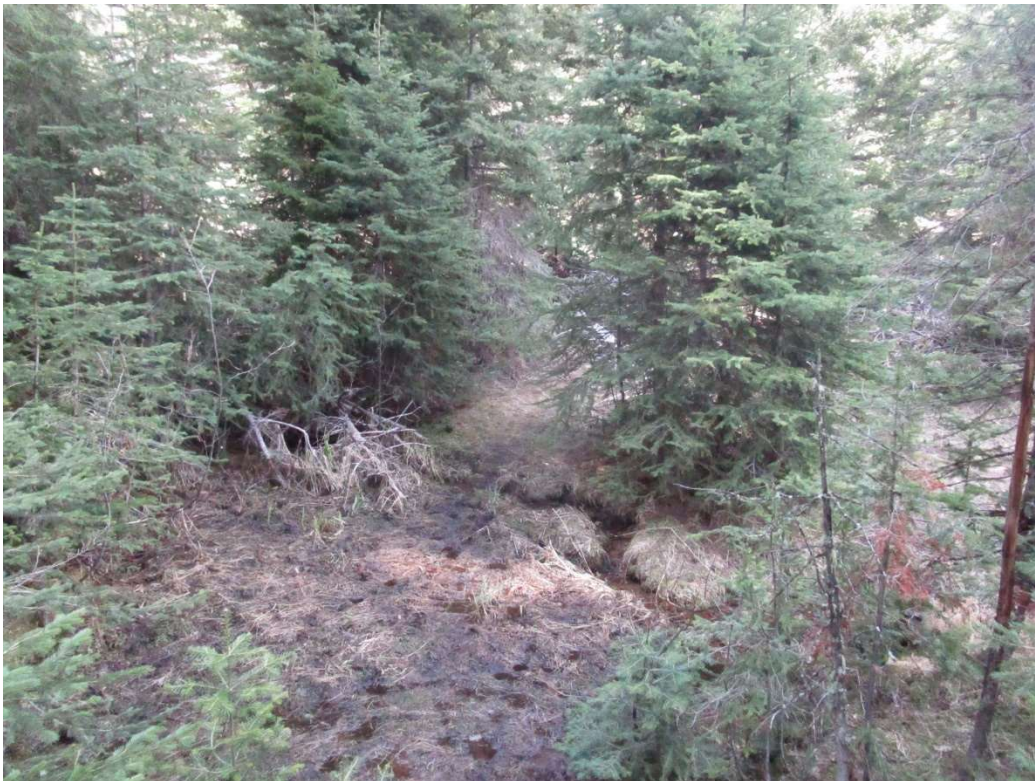
WAYPOINT 015 – Creek and groundwater flows with sedge and Douglas fir and subalpine fir regeneration, road significantly narrows after creek, NW photo direction.

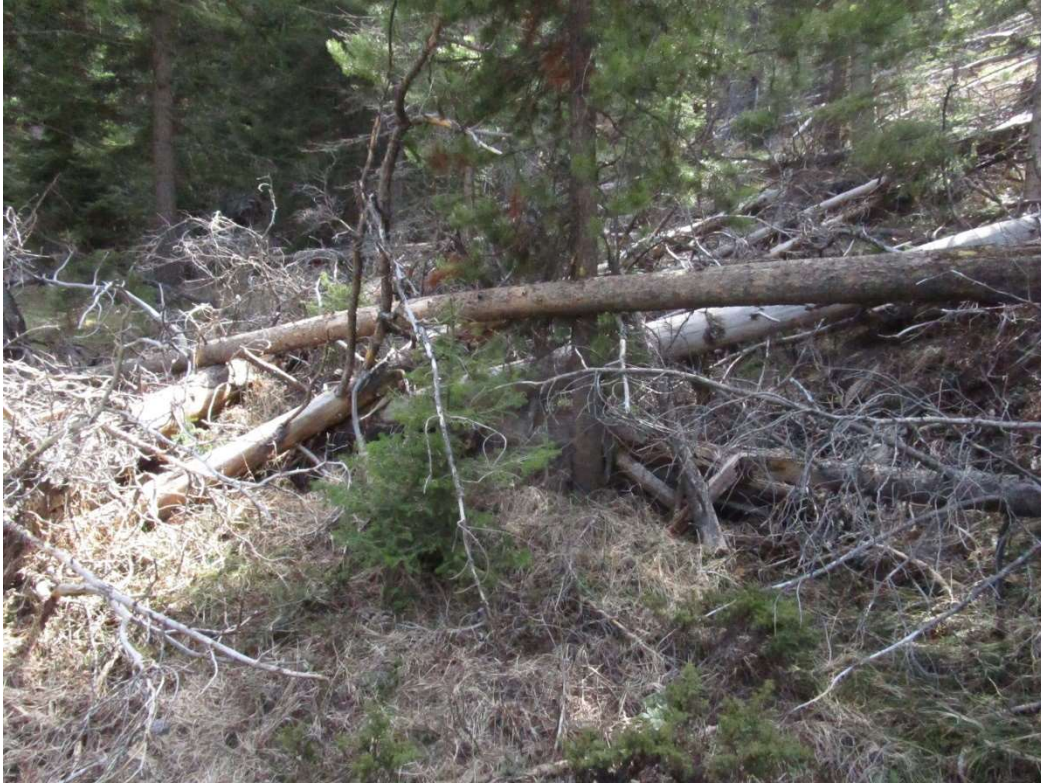
WAYPOINT 016 – End of #299-NS05. Road bed extremely difficult to see due to dead fall and Douglas fir and subalpine fir regeneration, SW photo direction.

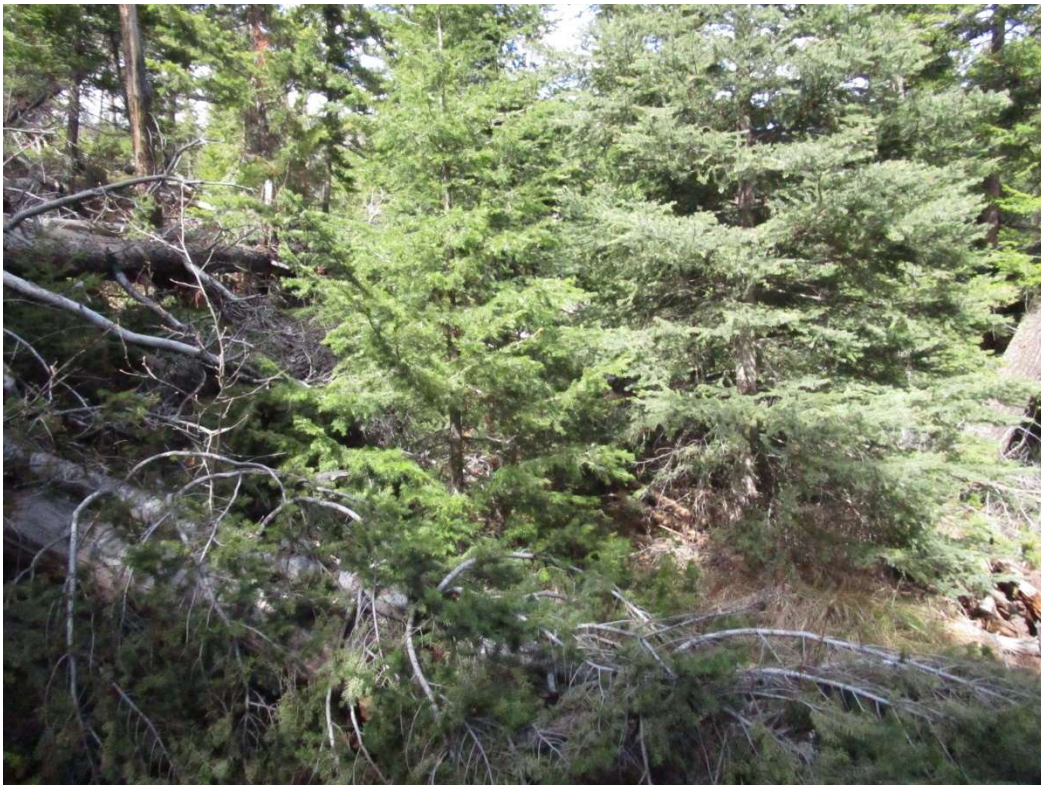
WAYPOINT 016 - End of #299-NS05. Road bed extremely difficult to see due to wall of dead fall and Douglas fir and subalpine fir regeneration, NE photo direction.

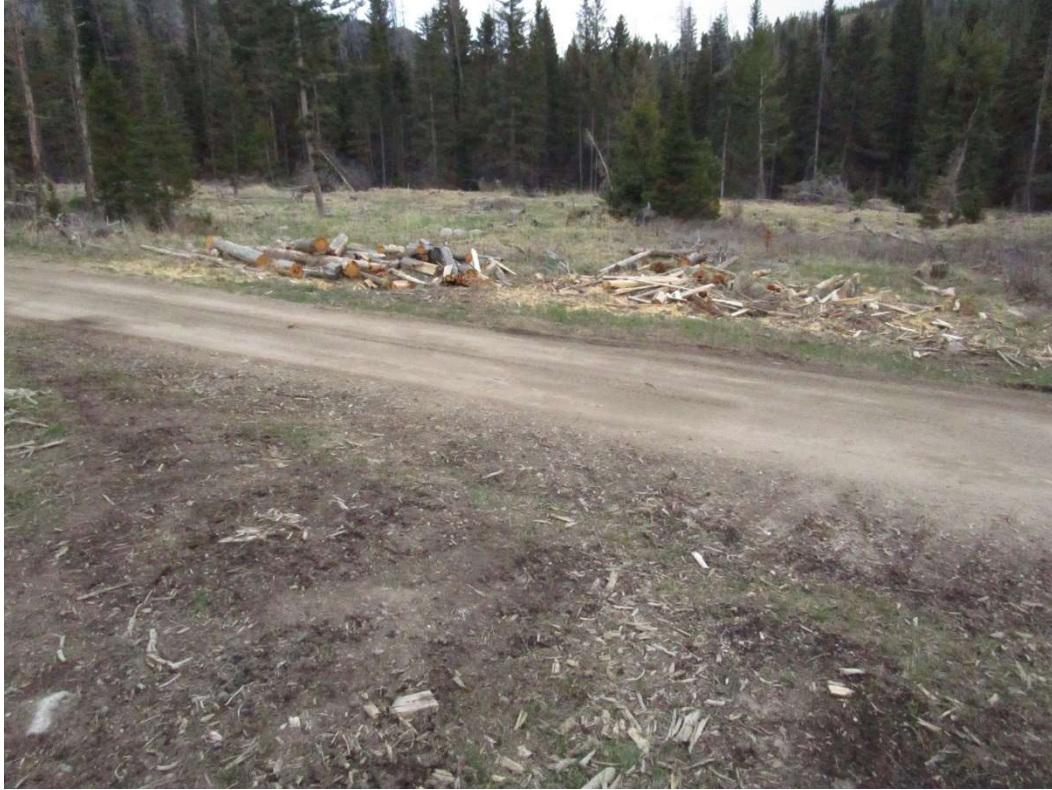
WAYPOINT 017 – Junction with Chessman Road and #299-C1, east photo direction.

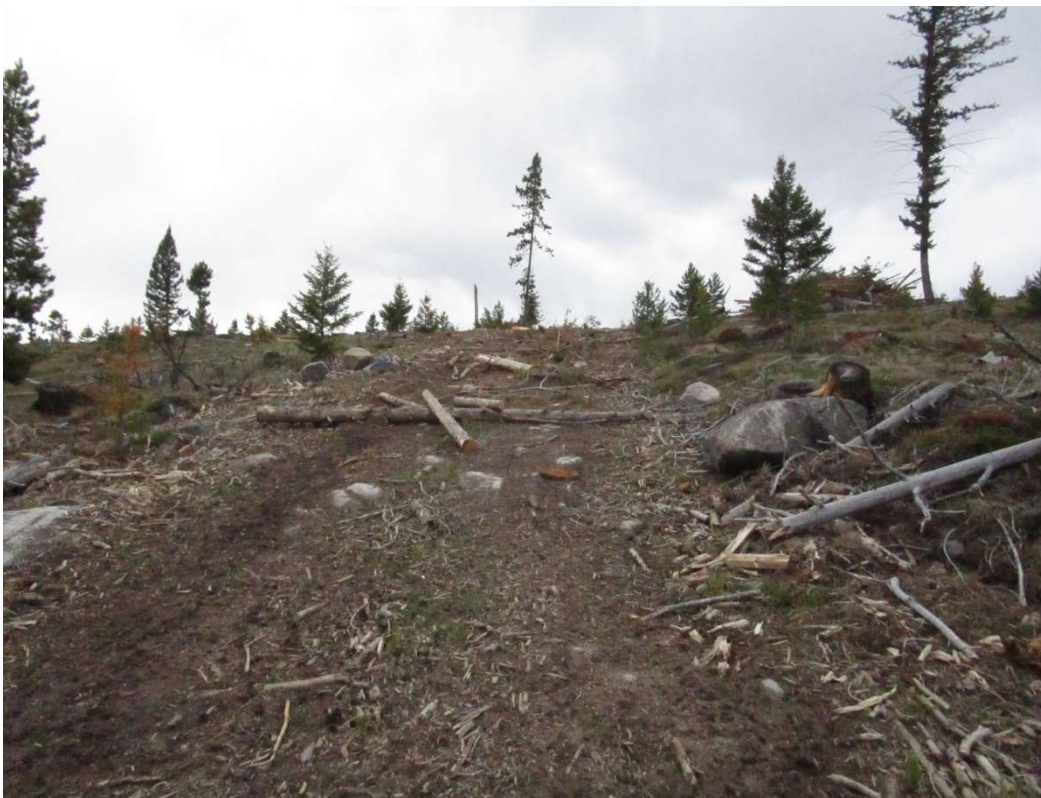
WAYPOINT 017 – Start of #299-C1. Logging road used for recent timber harvest, west photo direction.

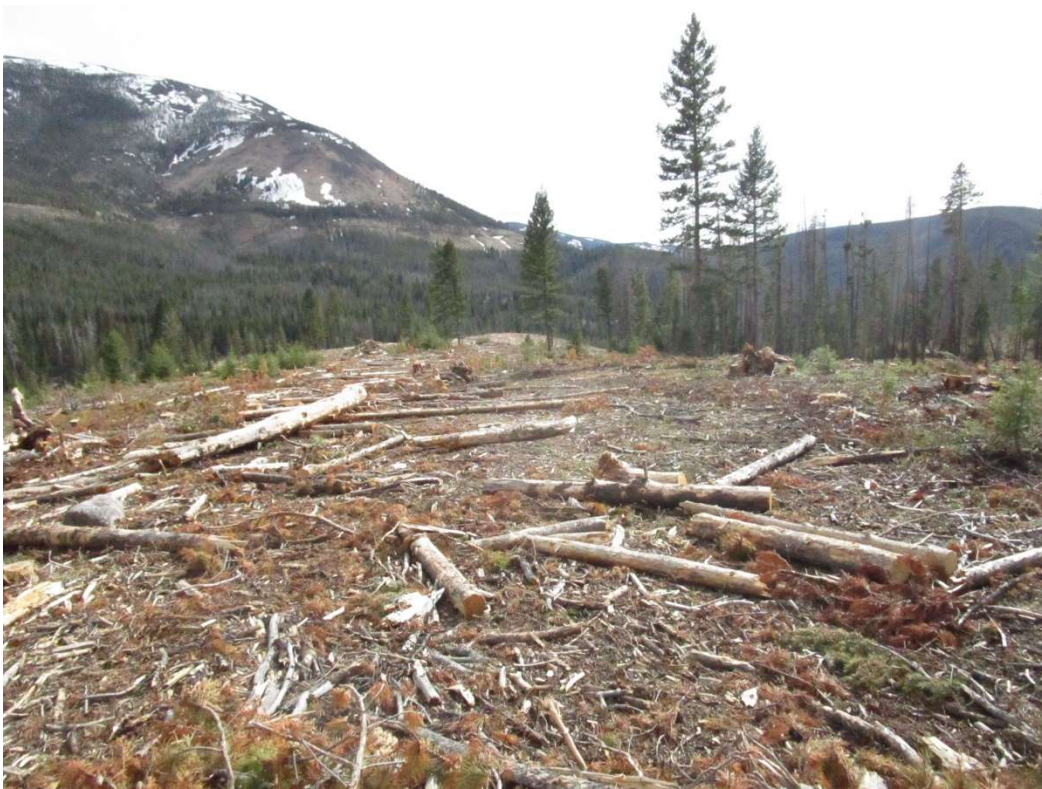
WAYPOINT 018 - Logging road used for recent timber harvest, SW photo direction, road bed difficult to distinguish due to woody debris.

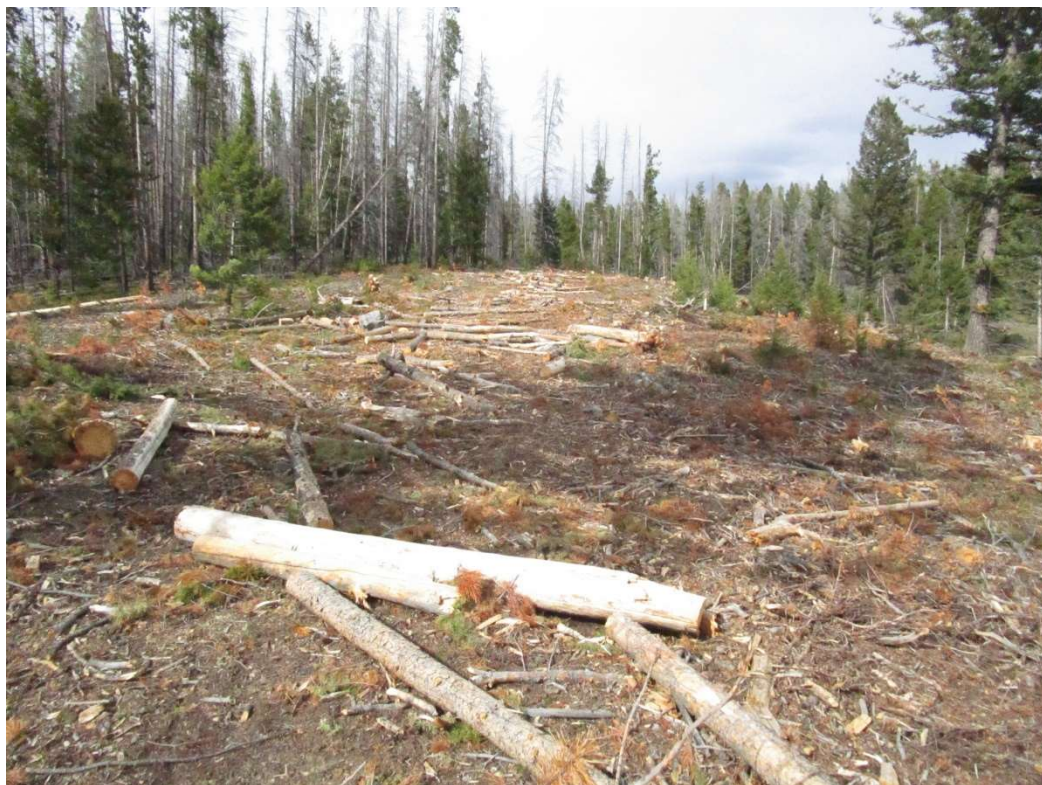
WAYPOINT 018 - Logging road used for recent timber harvest, NE photo direction, near Tenmile IRA boundary, road bed difficult to distinguish due to woody debris.

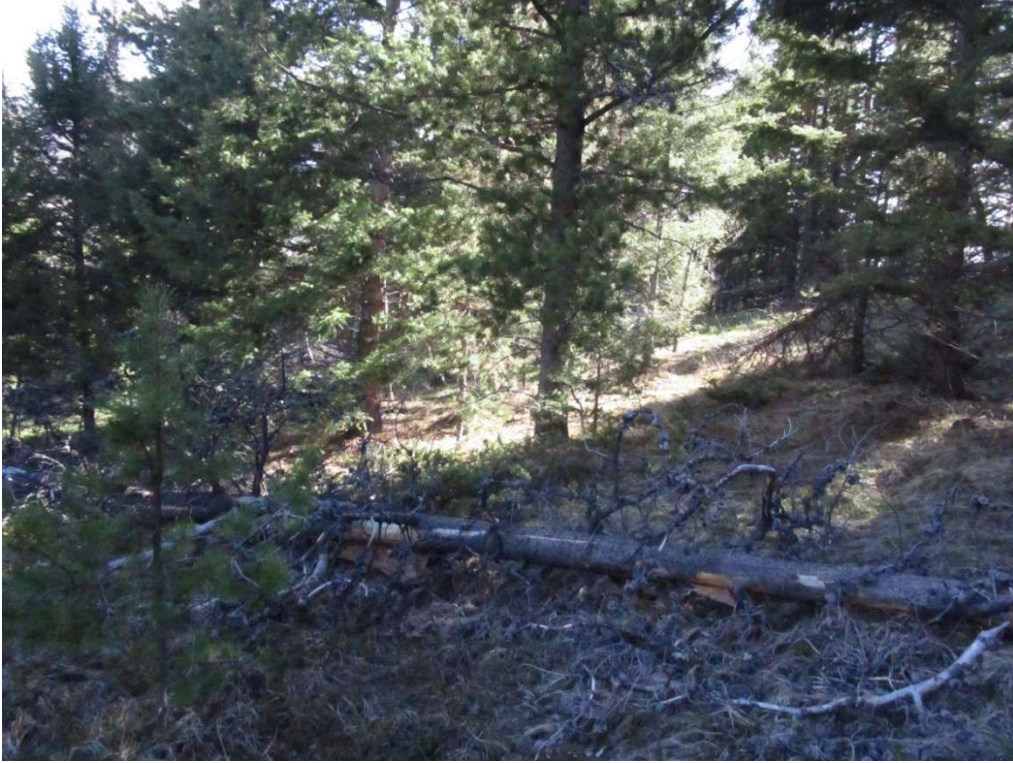
WAYPOINT 019 – End of #299-C1. Road bed or trail is indistinguishable due to forest regeneration and herbaceous undergrowth, SW photo direction.

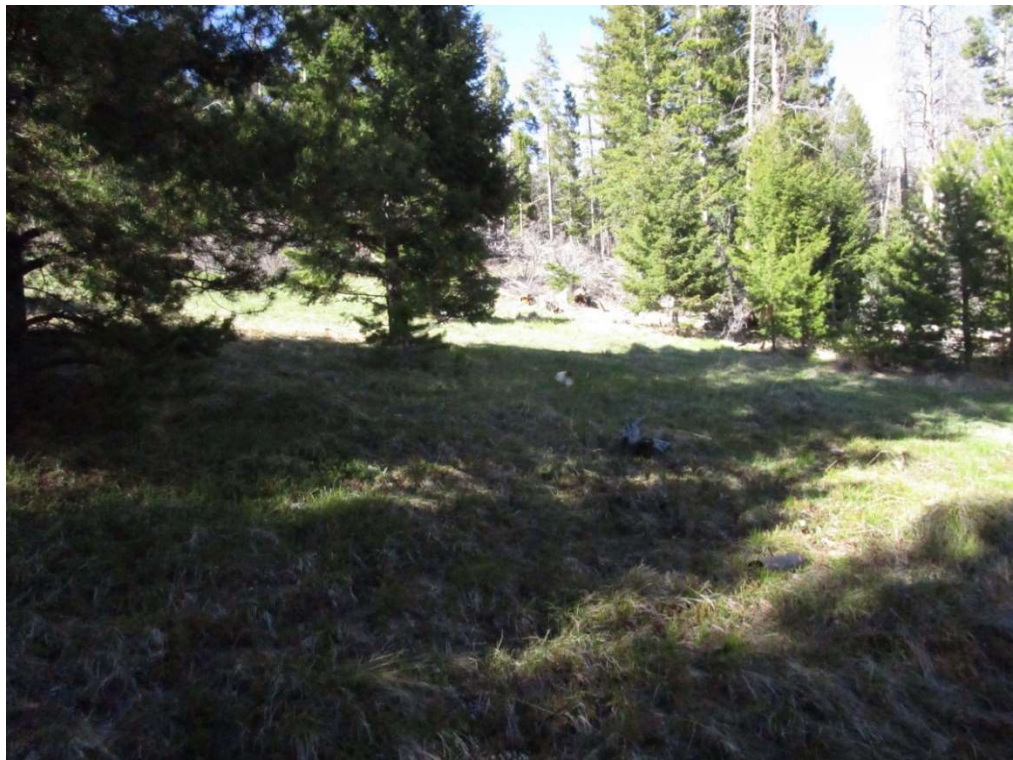
WAYPOINT 019 – End of #299-C1. Road bed or trail is indistinguishable due to forest regeneration and herbaceous undergrowth. According to map, “road” ends at abandoned mining cabin site in small clearing, NE photo direction.

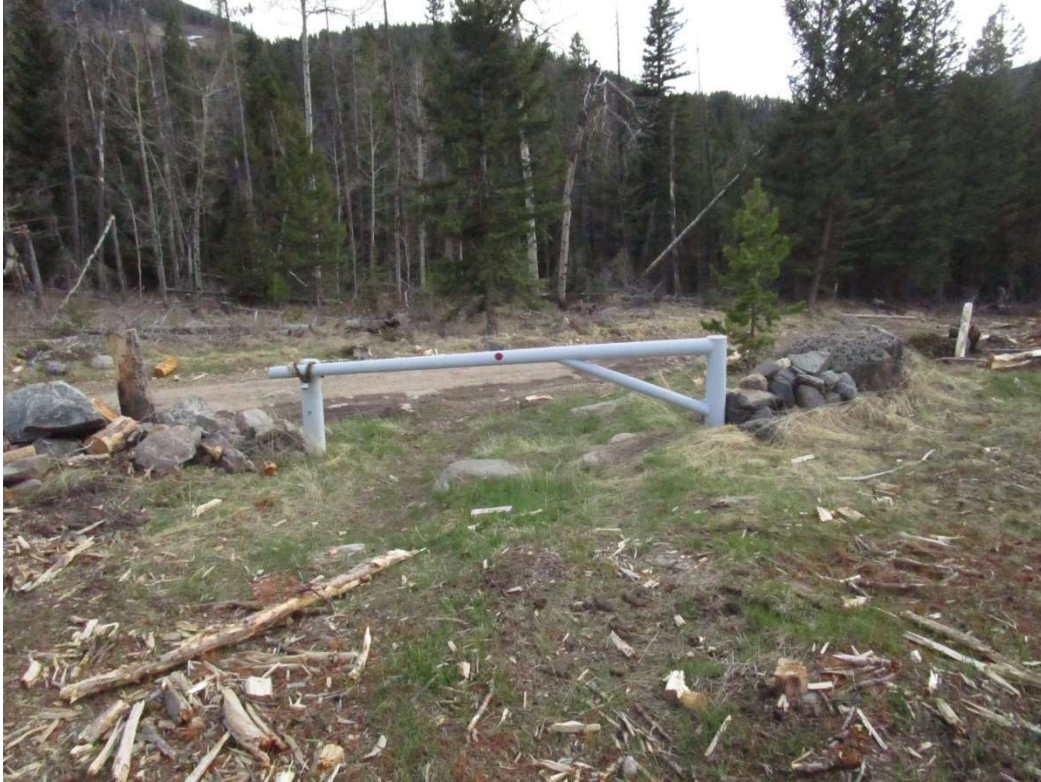
WAYPOINT 020 – Gated at junction of Chessman Road and #299-U001, SW photo direction, rocks and woody debris on road bed due to recent timber harvest.

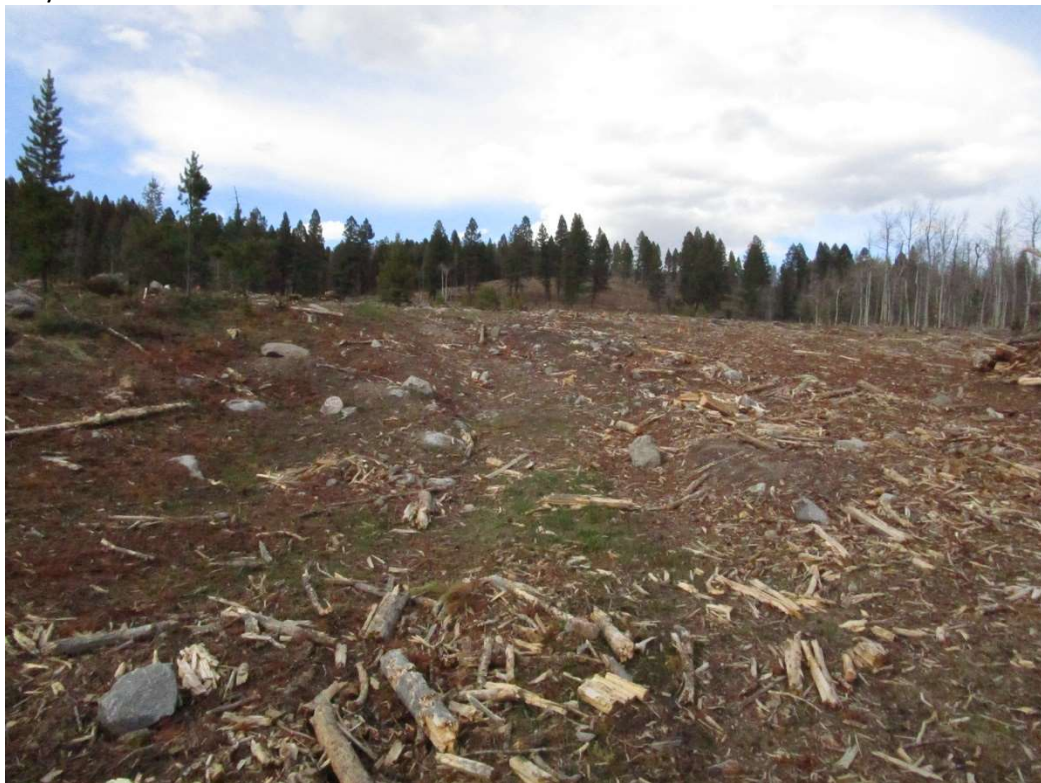
WAYPOINT 020 – Start of #299-C1. Two-track road going into recent timber harvest, NE photo direction, rocks and woody debris due to recent timber harvest.

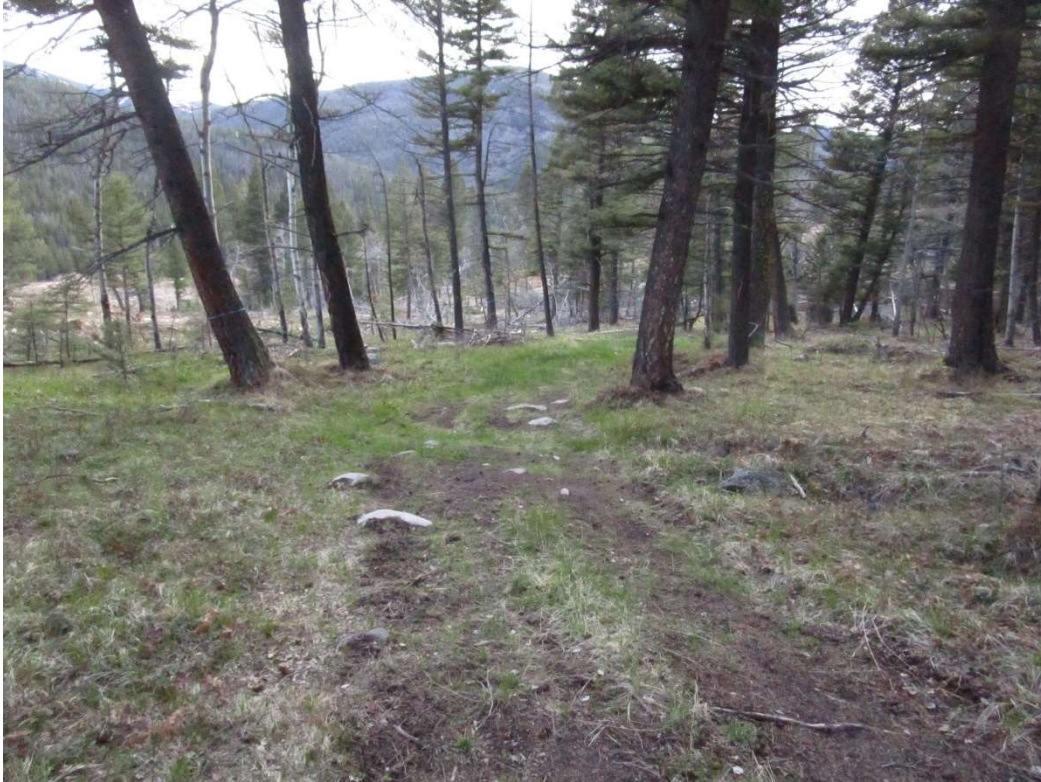
WAYPOINT 021 – Two-track near start of Tenmile IRA boundary, SW photo direction, some soil saturation and rocks.

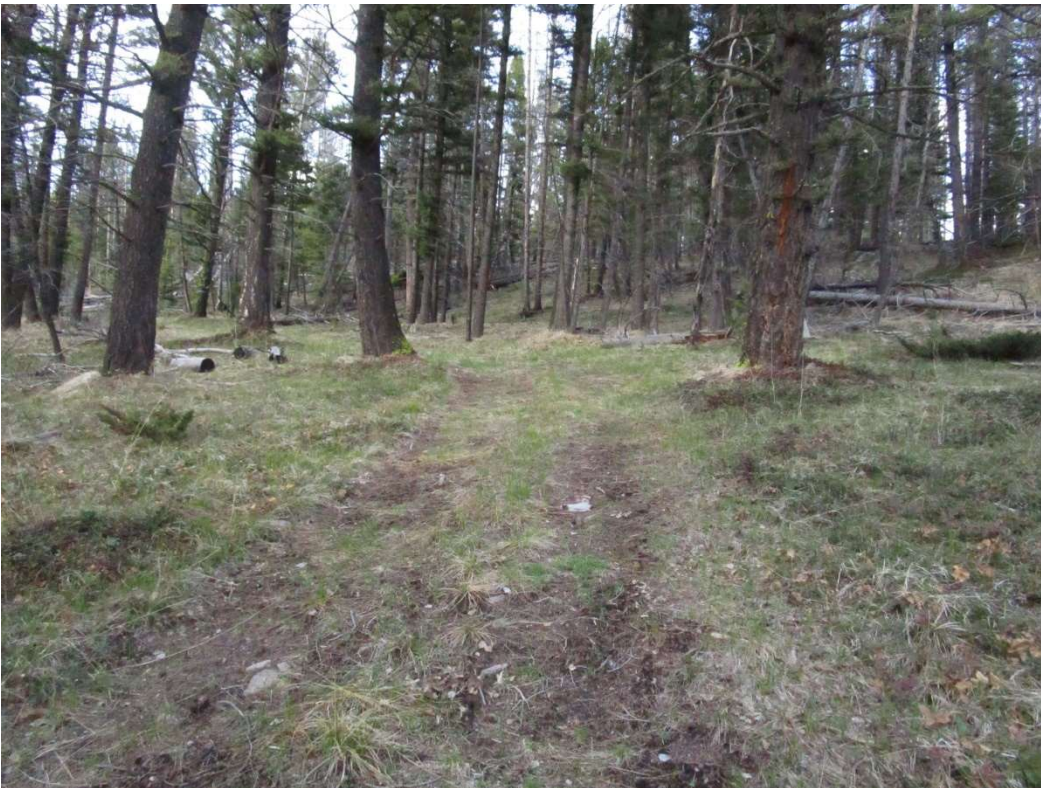
WAYPOINT 021 – Two-track near start of Tenmile IRA boundary, NE photo direction, some rocks.

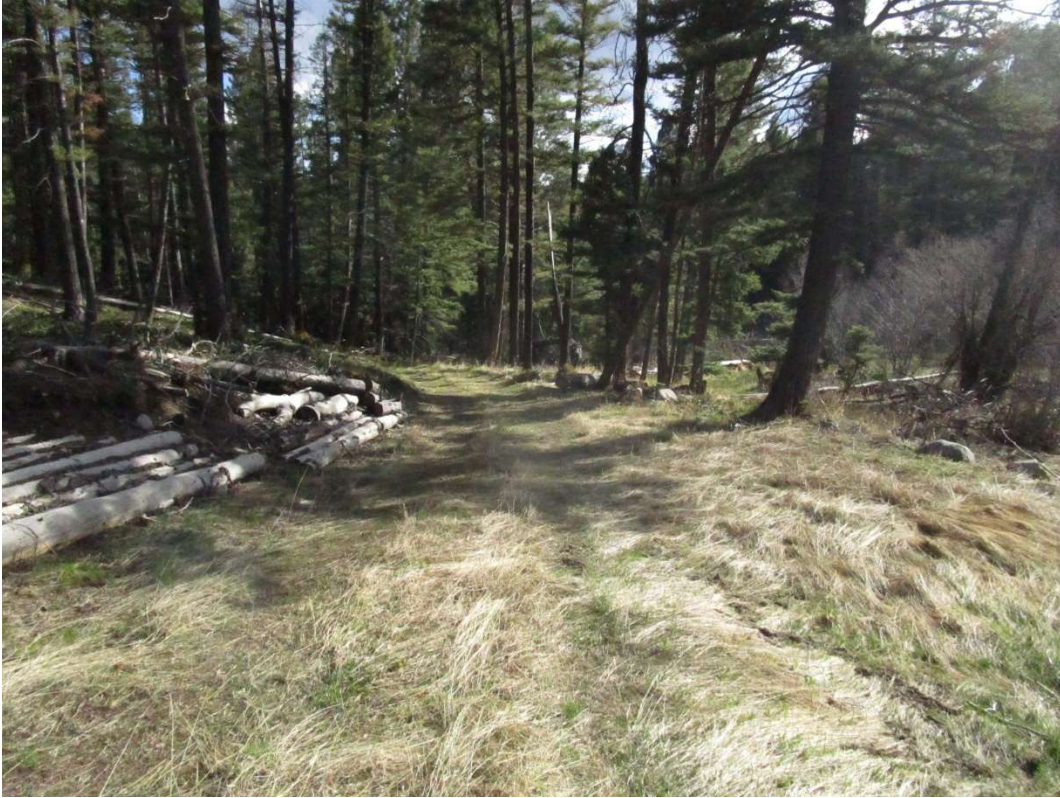
WAYPOINT 022 – End of #299-U001. Two-track used periodically and maintained for private property access, SW photo direction.

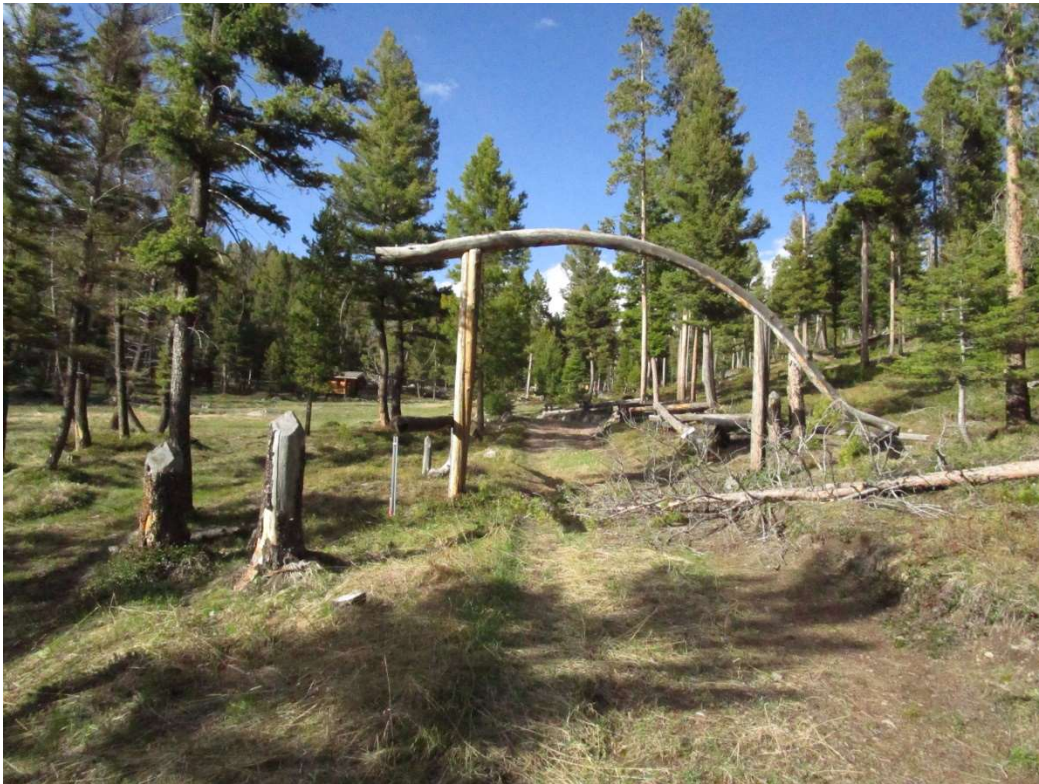
WAYPOINT 022 – End of #299-U001. Two-track continues onto private property, NE photo direction.
