LAZYMEN INVENTORIED ROADLESS AREA
SUBUNIT C – South and West Portion
Beaver Creek, Tenmile Creek, Moose Creek and Lazyman Creek
May 15, 2026

Subunit C: South and Western IRA includes drainages of Beaver Creek, Tenmile Creek, Moose Creek and Lazyman Creek

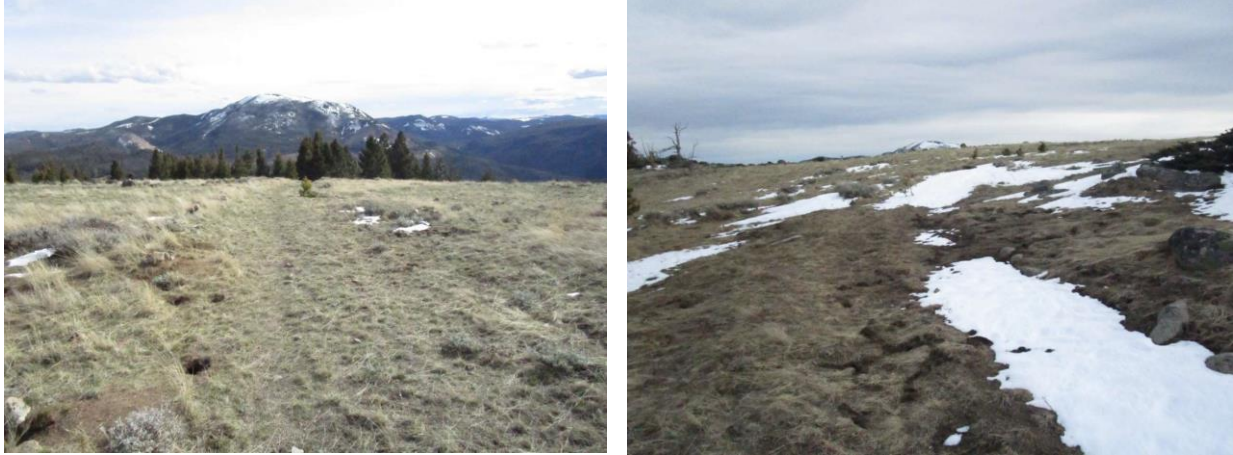
#4177 is barely distinguishable at times when it goes through grassy meadows where the road bed has been naturally revegetated with sagebrush and bluebunch wheatgrass.

In areas with forest canopy, there are conifer encroachment occurs due to mature Douglas fir, ponderosa pine, and lodgepole pine on the edges of the route as well as 1 to 4 foot tall

seedling/sapling regeneration within the “road” bed. There are also areas where there would need to be large rock and windblown dead fall removal for equipment to pass. The road bed varies from about 4 to 15 feet in width. No noxious weeds were observed during survey. Elk and deer sign was abundant throughout.

Figure C03. Barely distinguishable #4177 road bed with faint trail in grassy meadow. Some large rocks, SW photo direction, 4 foot width.

Figure C04. End of #4177 on top of Colorado Mountain. Old road bed, some rocks and herbaceous undergrowth, SE photo direction, 10 foot width.

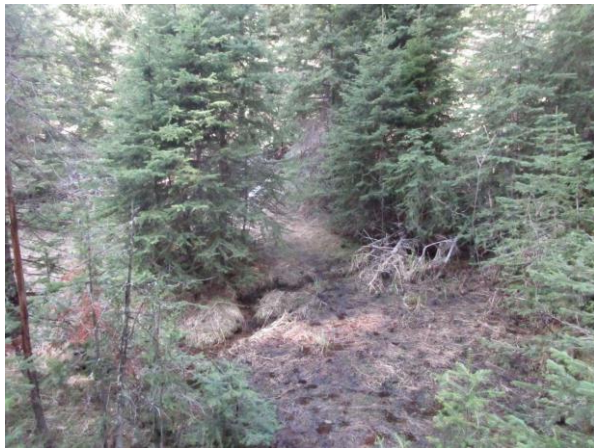
At the IRA boundary, 299-NS05 is blocked with downed trees and conifer regeneration. Within the IRA, large trees (>15" DBH were marked during timber surveys) and it is difficult to find the road bed due to windblown deadfall, herbaceous forest undergrowth, and regeneration of Douglas fir, lodgepole pine, and subalpine fir. The road crosses a creek/spring with current running water and soil saturation. The wetland system to the east of the road has survey stakes and marking on trees throughout, although logging activity was prevented with HHAA legal intervention.

Figure C06. At the end of 299-NS05, creek and groundwater flows with sedge and Douglas fir and subalpine fir regeneration. Waypoint 15.

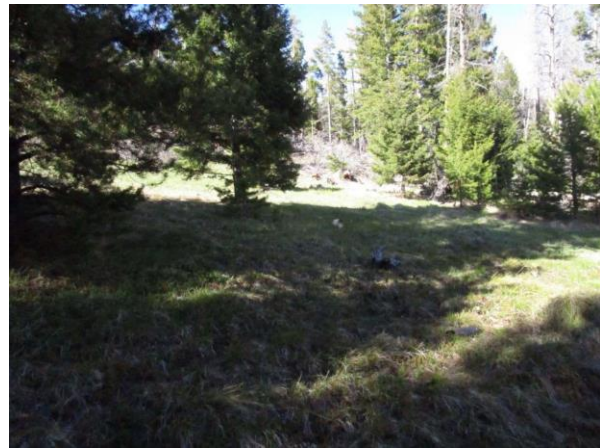
Figure C07. End of #299-C1. Road bed or trail is indistinguishable due to forest regeneration and herbaceous undergrowth (Waypoint 19). According to map, "road" ends at abandoned mining cabin site in small clearing, NE photo direction.

#299-C1 is not gated or marked in any way at the junction of Chessman Road. Logging has occurred up to the IRA boundary, but the "road" ends just before an abandoned mining cabin site and is non-existent once in the IRA. Except for common mullein (*Verbascum thapsus*), no noxious weeds were observed.

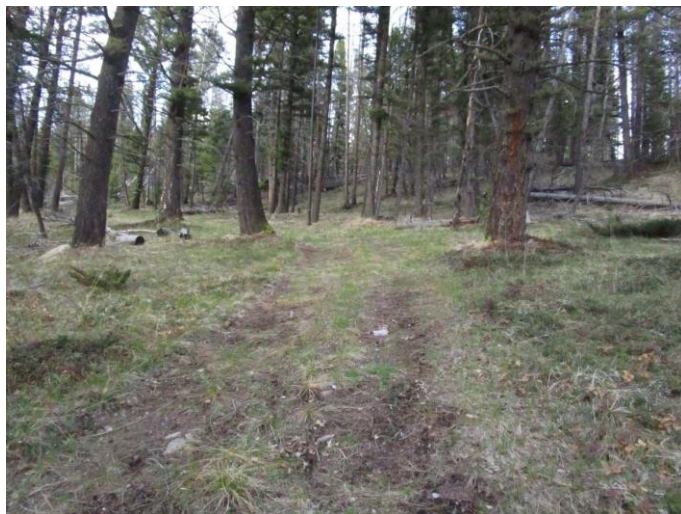
Figure C08. Two-track #299-U001 near start of Tenmile IRA boundary, some soil saturation and rocks. NE photo direction.

#299-U001 is a two-track that is gated at the junction of Chessman Road but the two-track continues into the Tenmile IRA. Marked trees occur along two-track in the IRA. The two-track appears to be periodically used and maintained for access to private land parcels located within the IRA.

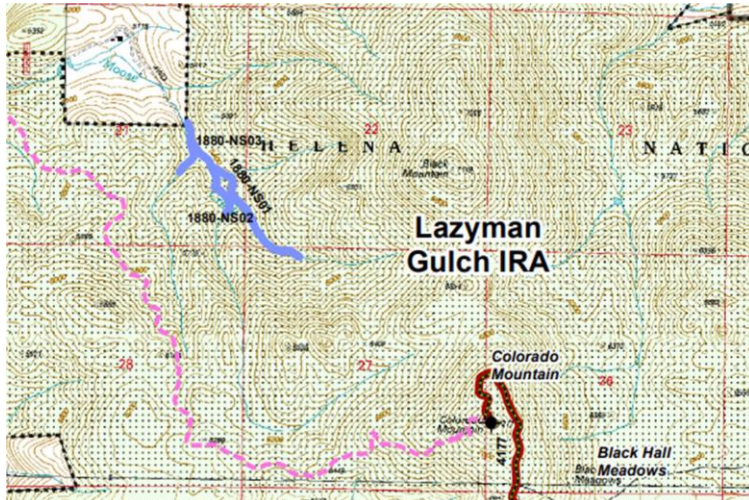
Figure C09. May 17, 2020 Moose Creek field surveys: 1880-NS01, NS02, NS03.

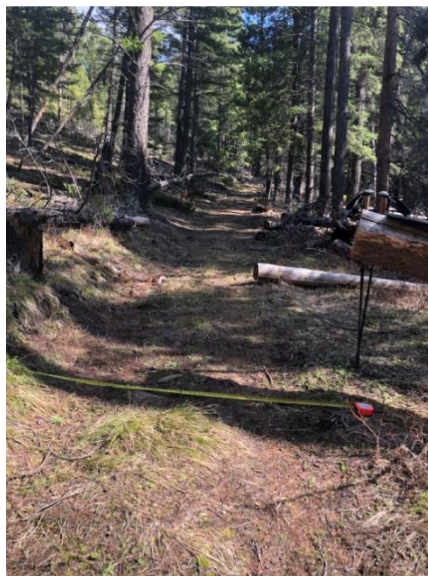
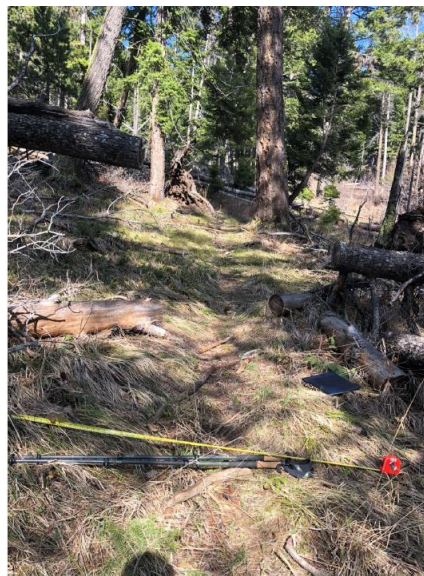
Gary Ingman reported, “1880-NS01 is the main road coming up the Moose Creek drainage from a 160 acre private inholding that effectively controls access to the area. There is a gate at the private property boundary below and this road extends up the creek into the upper reaches of Moose Creek. The road has been used by ATVs (some fresh tracks were noted) and has been cleared of blowdown, as evidenced by numerous cut logs thrown out of the trail. Some parts of the road could accommodate use by a smaller SUV or Jeep.

Figure C10. Evidence of routine trail clearing by ATV users. NS01-11. Roadbed is about 6-7 feet wide. Figure C11. NS01 turns into a horse or footpath. Looking up Moose Creek SE, tape=6’.

Over the course of its length, the road gradually narrows, crosses an old wooden foot bridge, and morphs into a horse or hunter footpath. Evidence of trail clearing extended into the footpath segment and beyond the end of road feature shown on the USFS transportation map. Vegetation in the lower reaches of the segment consists of mature lodgepole pine and medium sized Douglas-fir trees. The size of the fir trees increases further up the drainage and there are some very large trees at the end of the mapped segment. Trail clearing and motorized use on this trail is presumably illegal but goes largely unnoticed given the private landlocked nature of the setting. I skirted the private property to access this public segment before and after this survey, and it is difficult.”

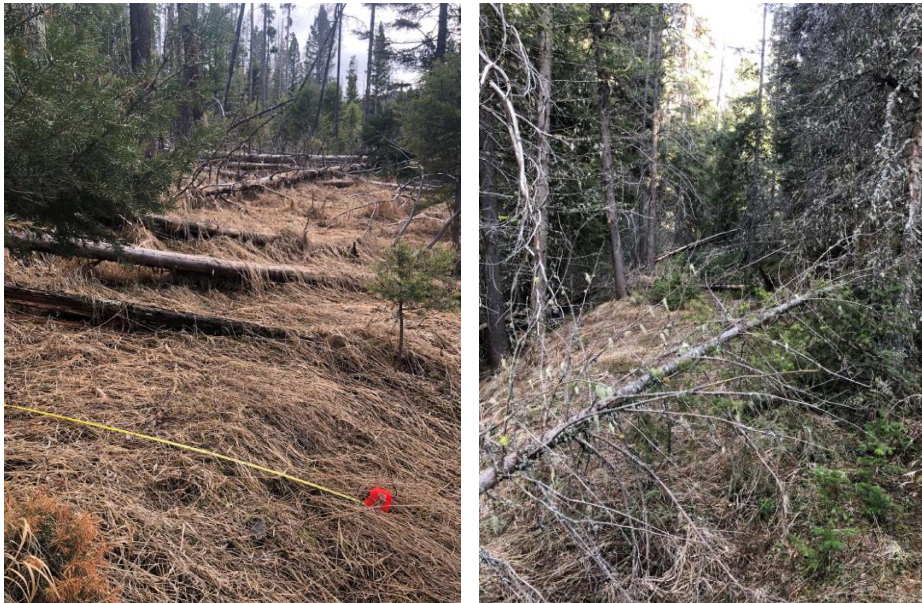
“1880-NS02 and NS03 - Only slight traces remain of an old mine prospecting access road. The routes are inundated with extensive blowdown and are difficult to pass on foot. They have largely been naturally obliterated and are fading into the landscape.”

NS03 parallels a tributary to Moose Creek with the stream course located approximately 6 feet from the edge of the roadway. The old roadbed was covered with numerous piles of moose droppings. Fresh elk tracks and droppings were present. Huge spruce and Douglas fir trees are present in this drainage, some of which are on the order of 5 feet dbh (diameter at breast height). Signs of human use in the form of trash, cleared trails or campsites were not observed.

Figure C12. Looking SW from upper reaches of NS03. Tape measure extended to 6 feet.

Figure C13. NS02 where it parallels Moose Creek. Looking NW; main Moose Creek to the left.

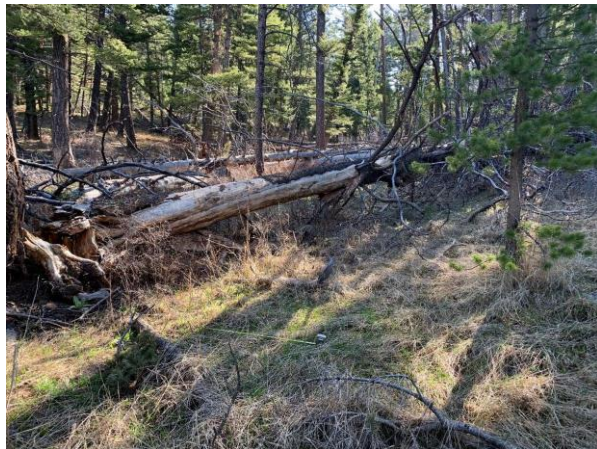
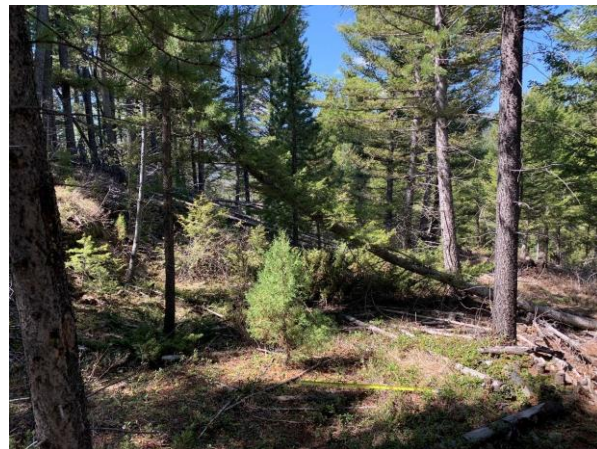
Before entering the IRA, Sovner described: an old logging road that was difficult to find, the beginning of the Tenmile Educational Trail, and cut saplings along a hiking trail. Once inside the IRA he reports, “Did not see any weeds during entire route. Much of the route was overgrown and in places hardly discernable from the natural landscape. Heavy sign of elk throughout.

Figures C15 and C16. Beginning and ending points of survey route 1813-NS01.

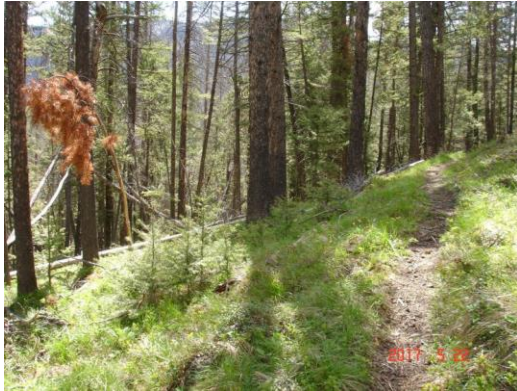
The Telegraph Trail gets its name from the old telegraph line that used to run between the Moose Creek historic cabin and the lookout (no longer present) at the crest of Colorado Mountain. The trail extends from the junction of Moose Creek with Tenmile Creek beginning in NE Section 20 and climbs in a southeasterly direction near the Moose-Tenmile divide through Sections 21 and 28 then turns east through the lower portion of Section 27, to the top of Colorado Mountain.

The nature of the historic Telegraph Trail (from the 1800's) has been damaged with trail expansion and cutting of huge trees that used to have the copper line insulators attached. Trees sporting insulators are still standing along portions of the trail that have not been expanded.

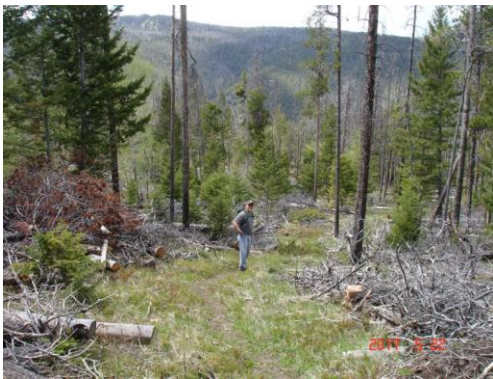
Figure C18. Expanded and cleared segment of the Telegraph Trail.

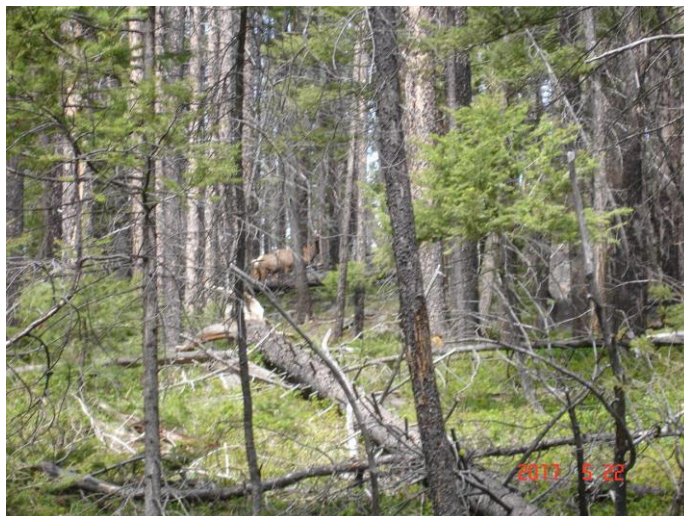
Figure C20. Elk observed May 22, 2017.

During the hike, coyote tracks and scat, 2 groups of elk – one group of 7 and the other group of about 30, were observed.

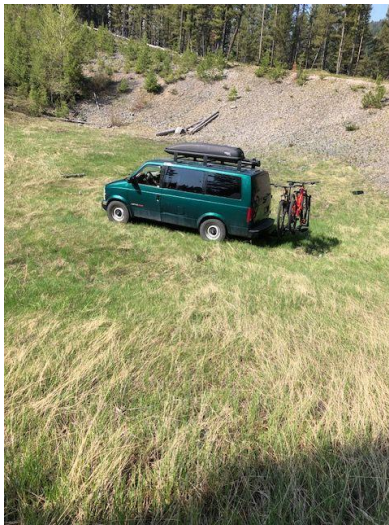
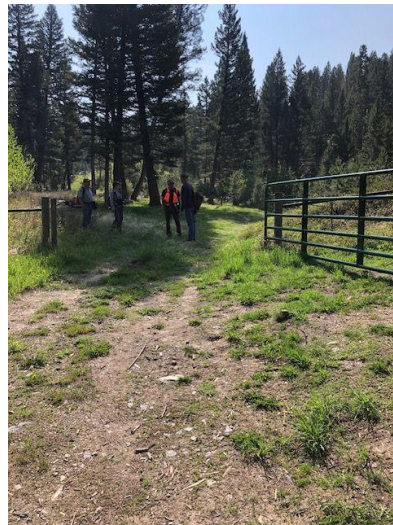
A summary of this report by Dennis Milburn notes: Observers departed the Tenmile Picnic Area at 09:30, traveling on the interpretive trail for access into the IRA. The gate on the road was swung open with no signage on appropriate use of the route for motor vehicles. The FS Divide Travel Plan shows the route to be a non-motorized trail. However, we immediately found a vehicle with 2 people who had evidently camped behind the open gate. They told us there were others camped further up the road which we found to include 3 more vehicles and 4 people.

Figure C21. Motorized campers with mountain bike behind the gate in the area closed to motorized use in Lazyman Creek.

Figure C22. Open gate at Lazyman Creek entrance without a sign indicating the area is closed to motorized use.

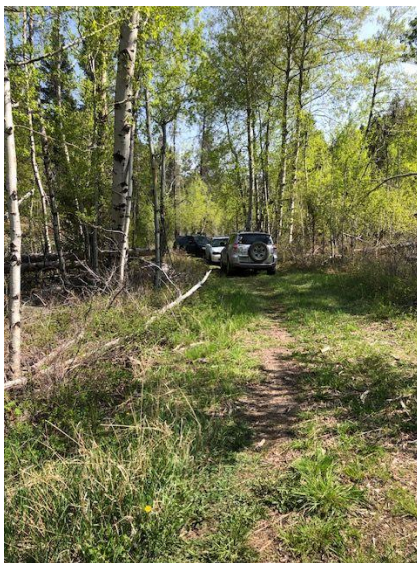
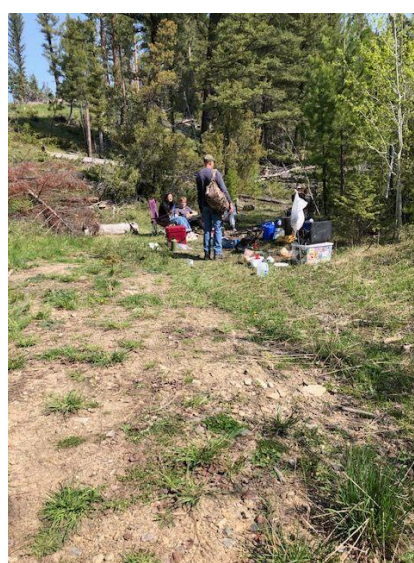
Figure C23. Three more vehicles behind the Lazyman Creek gate.

Figure C24. Campers associated with the three vehicles.

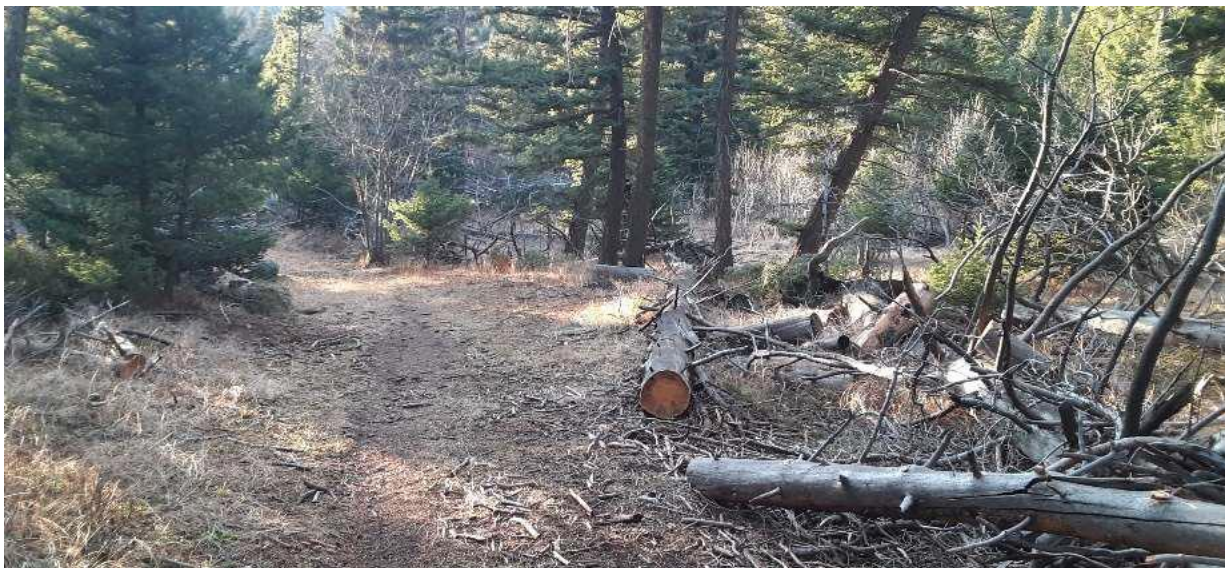
“On 11/11/2025, I accessed FS 299-B1 from the parking area off of Chessman Road near Rimini, MT (46.48390, -112.21611). While hiking, I noticed a huge increase in trail clearing and widening, as well as random, reasonless cutting and limbing of conifer saplings, sagebrush, and deciduous shrubs. The trail is now 15 feet wide all the way up to the parks. Width of the trail is enormous now and people have been driving side-by-sides and ATVs around the parking area rocks and through the wire fence gate all the way to the parks.

Some of this cutting and widening has occurred less than 100 feet from a surface water tributary that goes into Beaver Creek.

Figure 26. Trail along 299-B1 has been cut out for motorized access.

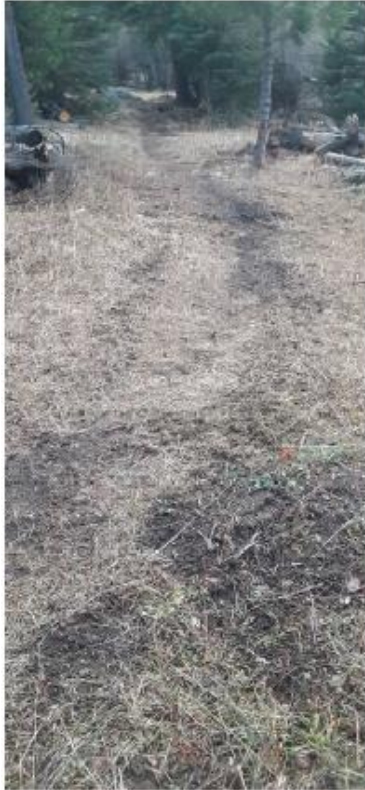
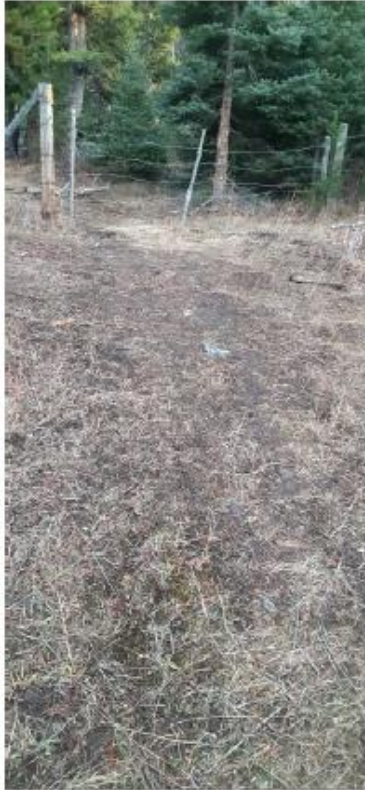
Figure C27. Gate on 299-B-1 was open with signs of recent ATV use.

Figure C28. Closed the gate to deter driving.

The wire fence gate (near 46.484694, -112.21520) was wide open on 11/11/2025; I untangled it and closed it. In recent years, there has been ongoing abuse of this area by folks on OHVs coming from Chessman Road. And now with this extreme widening of the trail, I fear the motorized abuse will be amplified and may soon enter the Lazyman IRA boundary and eventually go up to the summit of Colorado Mountain.

I am interested in seeing a more obvious closure sign put up and a more robust gate at the parking area that OHV can't drive around. The fence is down, and people can drive around the big rocks. Please see the photos I included in this submission. (Additional photos are in FS299-B1_Nov25Westfal) Photos were taken from the parking area to where the trail splits and goes to Black Hall Meadows."

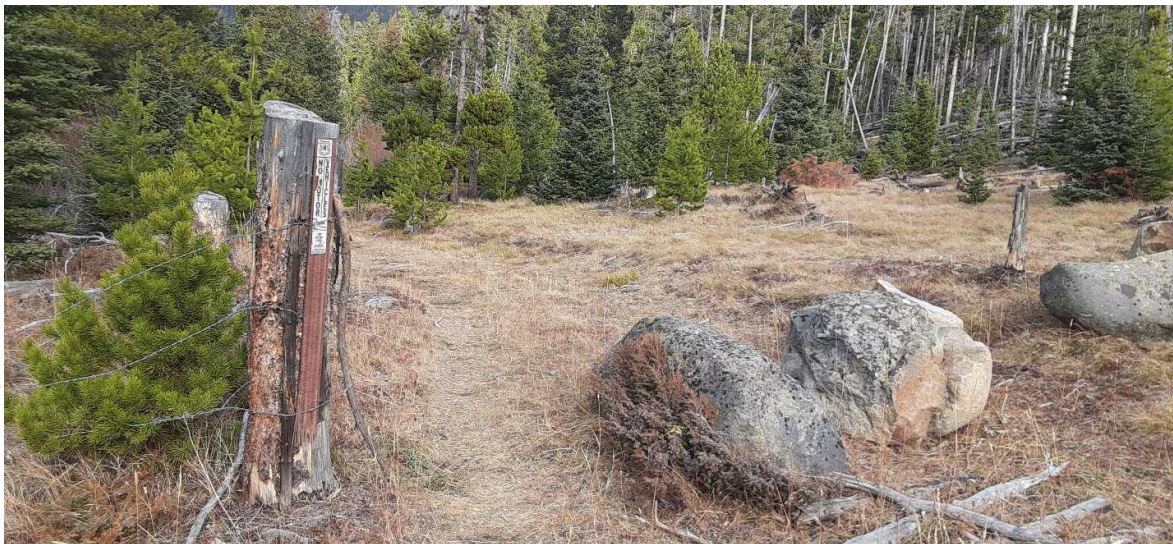
Figure C29. Better closure sign (more obvious) and robust gate should be installed at parking area - 299-B1.

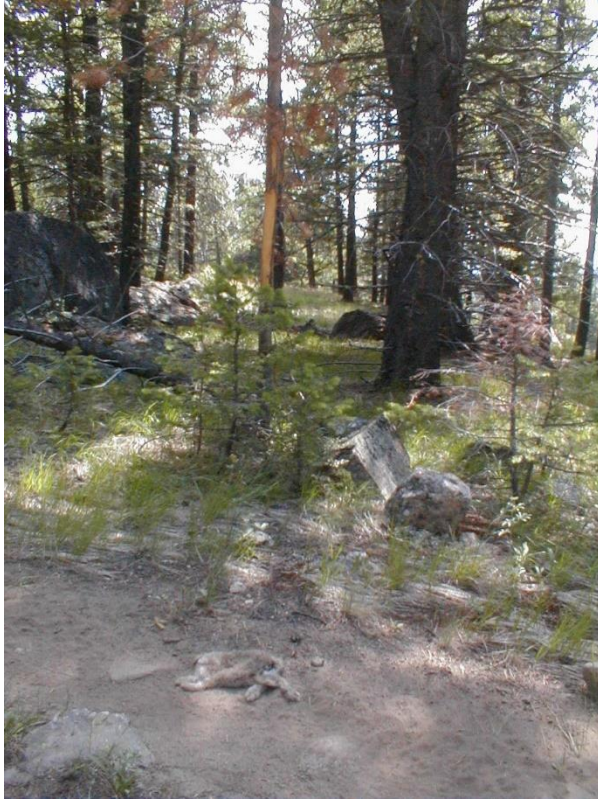
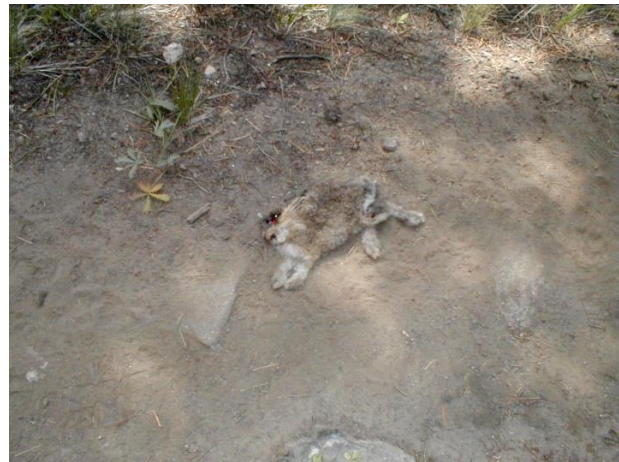
Figure C30 and C31. Snowshoe hare recently run over by ATV on trail just outside the Lazyman IRA.

accidentally and sometime purposefully run over as in these photos of a snowshoe hare and a boreal toad. The non-motorized nature of Inventoried Roadless Areas are beyond measure for wildlife.
