## #299-NS05, 299-C1, 299-U001 (Beaver Creek)

## SURVEY OF #299 Series Roads

Waypoints 012 – 016 (#299-NS05), 017 – 019 (#299-C1), 020 – 022 (#299-U001)

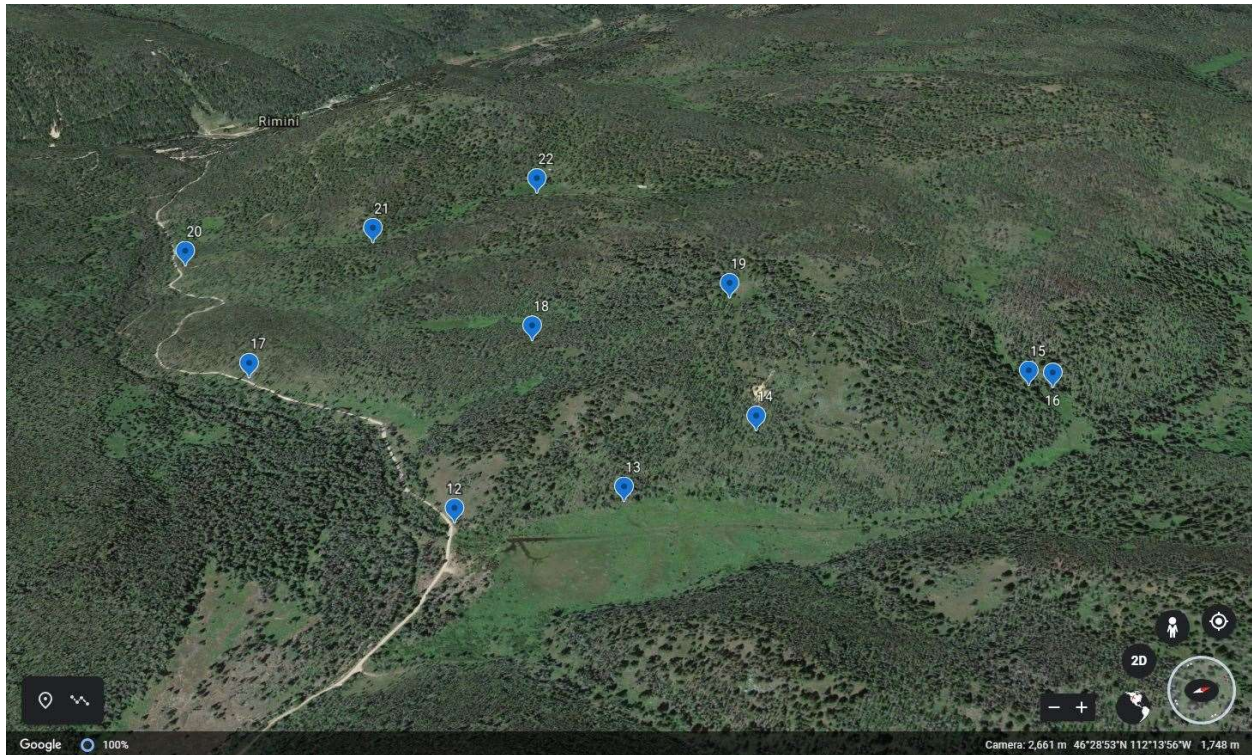
#299-NS05 (Waypoints 012-016), #299-C1 (Waypoints 017-019), and #299-U001 (Waypoints 020 – 022)

**#299-NS05:** The road is blocked with large rocks at the junction of Chessman Road. It was used for a recent timber harvest. Evidence of recent road use and timber harvest stop at the Tenmile IRA boundary. At the IRA boundary, the road is blocked with downed trees and conifer regeneration. Within the IRA, large trees (>15 DBH were marked during timber surveys) and it is difficult to find the road bed due to wind blown deadfall, herbaceous forest undergrowth, and regeneration of Douglas fir, lodgepole pine, and subalpine fir. The road crosses a creek/spring with current running water and soil saturation. The wetland system to the east of the road has survey stakes and marking on trees throughout. Only Lewis and Clark county listed noxious weed, common mullein (*Verbascum thapsus*), was observed near the road bed during field surveys. The road width is about 15-18 feet wide within the recent timber harvest, and within the IRA, the road gradually narrows from about 15 to 10 feet wide.

**#299-C1:** The road is not gated or marked in any way at the junction of Chessman Road. It was used for a recent timber harvest and is difficult to distinguish where the road bed is due because it is covered in woody debris. Evidence of timber harvest ceases just before Tenmile IRA boundary. Some marked trees (mainly >15 inch DBH Douglas fir) continue into IRA. The "road" is completely non-existent once inside the IRA due to blown down dead fall and conifer and forest understory regeneration. According to the maps, it seems the road ends just before an abandoned mining cabin site. For use of the "road", once inside the IRA, tree removal will be a necessary improvement, as there is currently no distinguishable road bed. Live tree removal of Douglas fir ranging from 6 to >15 inch DBH, lodgepole pine ranging 8 to 12 inch DBH, and subalpine fir ranging from 6 to 8 inch DBH as well as 1 to 4 foot tall Douglas fir and lodgepole pine seedlings/saplings scattered. Only Lewis and Clark county listed noxious weed, common mullein (*Verbascum thapsus*), was observed near the road bed during field surveys. The road width is about 20-25 feet wide within the recent timber harvest, but the road bed is non-existent once in the IRA.

**#299-U001:** The two-track road is gated at the junction of Chessman Road. It was used for a recent timber harvest and is covered in woody debris. Timber harvest ceases, but two track continues into Tenmile IRA. Marked trees continue along two-track in the IRA. Two track appears to be periodically used and maintained for access to private land parcels located within the IRA. The roadway is vegetated with grass and forb species and there is no conifer regeneration in the road bed; some winter blow down has occurred across the road. Near the boundary of the IRA there is some standing water and soil saturation due to a spring. There is a primitive bridge crossing over a wet area within the IRA (located at 46.48362, -112.23028). The private land parcels appear to have at least three log cabin structures as well as other buildings. No noxious weeds were observed during field surveys. The road width is about 12-15 feet at the junction of Chessman Road and it tapers to about 10 feet wide at the Tenmile IRA boundary.

Google Earth screen-shot of Chessman Road and Beaver Creek area, #299-NS05, #299-C1, and #299-U001 in Tenmile IRA. The bottom center shows the wetland meadow which connects to Beaver Creek. Chessman Road, which follows Beaver Creek, is on the left side of the image where Waypoints 12, 17, and 20 connect to each #299 series road. Rimini Road and the town of Rimini can be seen in the top left of the image.
